Investigative Report on ELW Master Drainage for the Community Association

Introduction

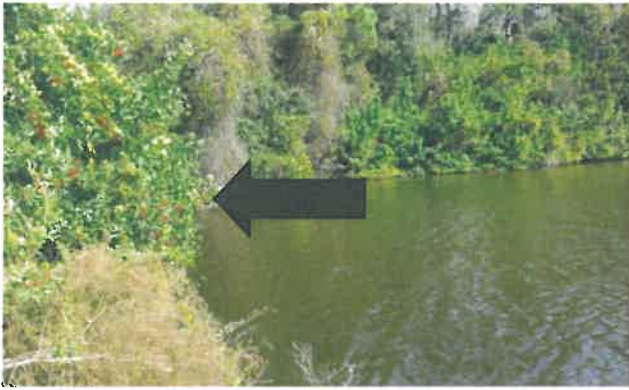
Proceeding upstream to Structure 2BC-1, supposedly constructed in the northerly end of the retention pond located immediately east of Diamond Crest, was not found during our Investigation. We are assuming that it exists, but due to the presence of heavy vegetation existing on the lake bank and surrounding area in the vicinity of the Structure, we were unable to access and were prevented from inspecting the structure. According to information shown on Archived Plans, Structure 2BC-1 is supposedly a weir structure, with a 30 inch pipe connecting to the retention pond located on the north side of North Golf Hole Number 11, at the tee area. The area needs to be cleared and the weir examined and possibly maintained, and access to the structure should be continuously allowed.

Structure 2BC-1, arrow points to location where plans show structure to be.

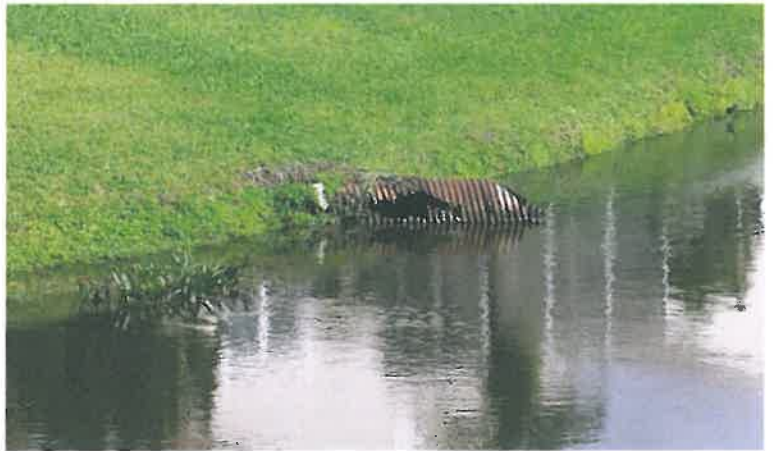
Structure 2BC-2

erosion previously mentioned. Structure 2BC-2, which is a mitered end metal or aluminum pipe on the end of a pipe inflow, and appears to convey drainage from a portion of East Lake Woodlands Parkway, is partially exposed which again indicates that the water level in the retention pond is likely existing at an elevation lower than its designed intent. The pipe, at least at the discharge end, needs to be replaced, and the water levels in the retention ponds should be restored to their originally intended elevation by repair/replacement of Structures 2BC-3 and 2BC-4.

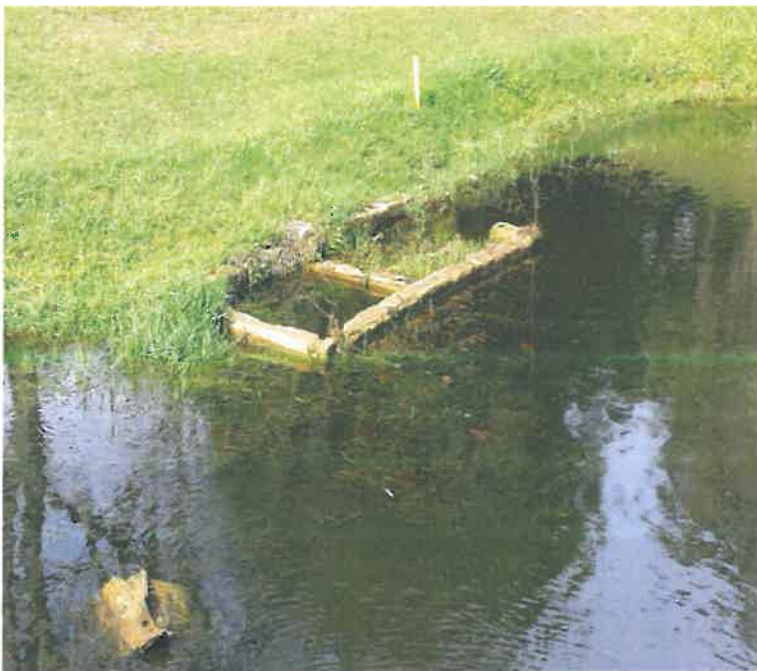
Structure 2BC-3

Proceeding upstream, Structure 2BC-3, which was originally also constructed as a weir structure, interconnects the retention ponds located on North Golf Holes 9 and 10 with double 36" RCP, appears to be damaged and needs to be restored as previously constructed.

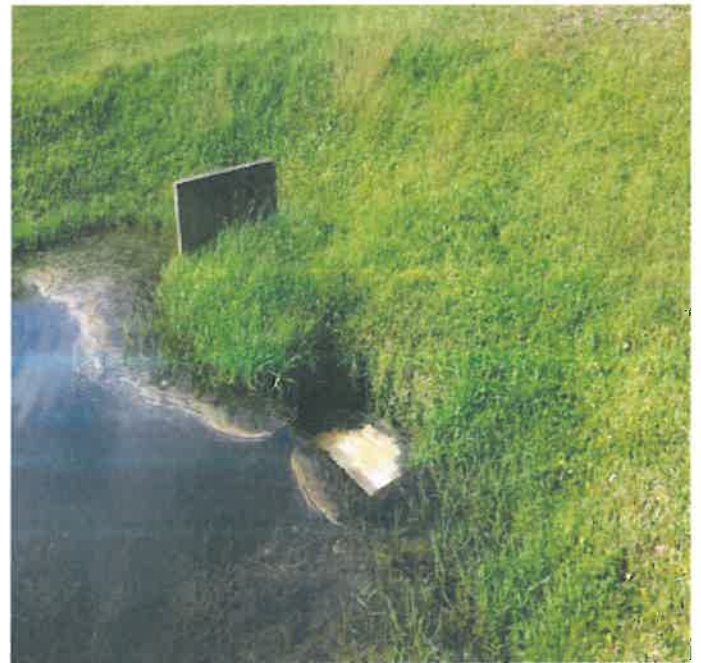
Structure 2BC-4

Additionally, Structure 2BC-4, which is located immediately upstream at North Golf Hole number 9 tee, and according to archived master plans which we found for the East Lake Woodlands Community improvements (Archived Plans), was originally constructed as the most downstream discharge control structure (weir) for Channel 2BC, with twin 42 inch pipe outfalling into the ditch on the north side of Golf Hole Number 8. The structure appears to no longer exist as a weir structure (see photo), and it appears that one of the 42 inch pipes is either partially or totally blocked by sediment and vegetation. As this weir was designed and intended to convey drainage from all the improved areas mentioned above, this structure and pipe system needs to be repaired/replaced to its' originally constructed condition. Additionally, this structure controls the normal water levels in the retention ponds located on North Golf Holes 9, 10 and 11. It appears that the water levels in these retention ponds currently exist more than a half of a foot below their normal design elevations. Although this is not necessarily a significant drainage concern, lower-than-intended water levels in the retention ponds are both aesthetically unpleasing, and more importantly, are subject to substantial lake bank erosion problems, which ultimately could be a source of sediment blockage of the Channel and/or structures.

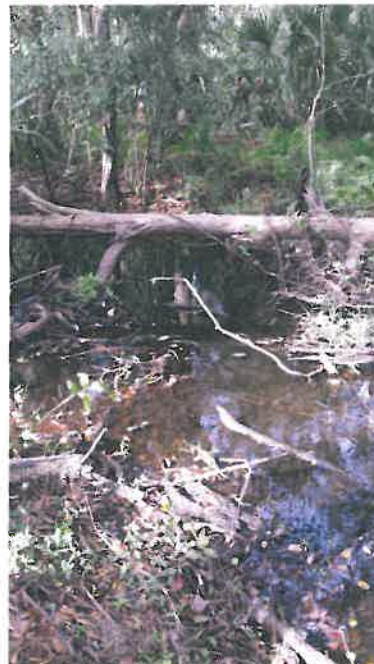
The most downstream drainage structure for the Channel prior to connection and outfall into Brooker Creek, is the existing ditch along the north side of North Golf Hole Number 8. Its' function as an adequate conveyor of drainage is impeded by the presence of fallen tree limbs and branches, which are partially and significantly blocking the intended flow. This ditch system needs to be cleaned and restored to its' original condition prior to a worsening of its' condition, and further blockage of the ditch conveyance system.

View downstream of Structure 2BC-4

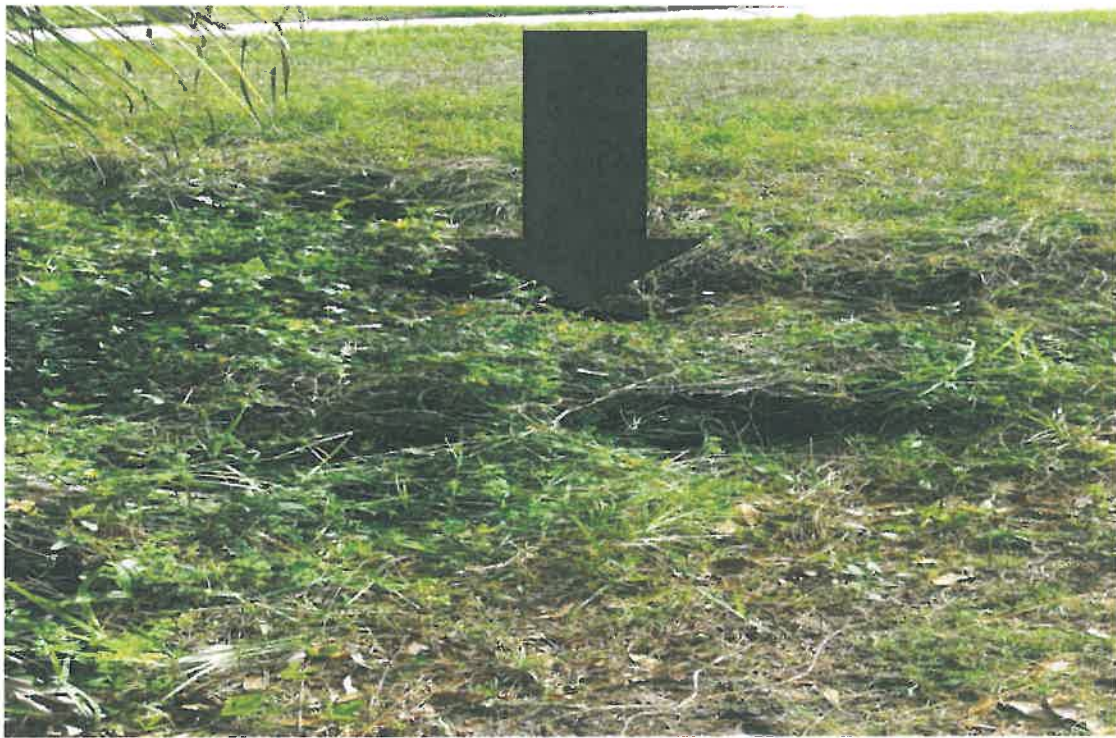
Structure 3BC-1

Channel 3BC conveys the storm water flow collected in Channel MF, conveying storm water discharge which is predominately outfalled from the large conservation area located west of North Golf Course Hole 12, and north of North Golf Course Hole 13. Channel MF conveys drainage runoff from this area, discharges it across East Lake Woodlands Parkway through structures 3BC-1 and MF-1 via twin 36 inch pipes, and then continues into Channel 3BC. Channel 3BC exists through the riverine system located in the Conservation Area located between Turtle Creeks Three and Four, and then ultimately directs storm water outfall discharges into Brooker Creek via downstream twin 36 inch pipes located under Turtle Creek Trail. We learned from our inspection that these pipes were recently cleaned and maintained, apparently as a result of a report recommendation that EMK performed for the Turtle Creek HOA, entitled Report on Investigation of Drainage Improvements at East Lake Woodlands Turtle Creek Units Three and Four. However Structures 3BC-1 and MF-1, which convey the drainage outfall for Channel MF, under East Lake Woodlands Parkway, are in need of substantial cleaning and maintenance, as both structures are barely visible, caused by an intense accumulation of invasive vegetation and sediment.

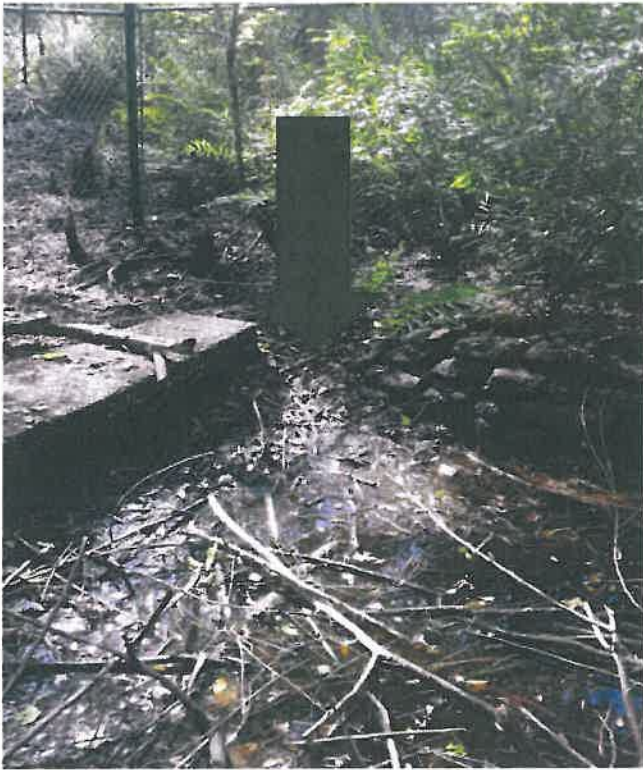
Channel 1FL conveys storm water from a significant amount of the Development Parcels, and a rather large offsite contribution (one of two total) from the Forest Lakes Community immediately east of East Lake Woodlands. On-site Development Parcels which rely on this Channel for drainage conveyance include Greenhaven Units 2, 3 and 4, small portions of Aberdeen Units One and Two, and North Golf Course Holes 2, 3, and 4. Starting at the most upstream structure and proceeding downstream, Structure 1FL-1, which was constructed as a straight concrete wall, was intended to serve as a control weir to regulate inflows from the off-site Forest Lakes Community. The weir has been eroded (breached) to a point where the inflow from the offsite facility is by-passing the intended weir control structure, likely allowing more flows to come on site from the Forest Lakes Community than what was originally intended. This breach needs to be properly repaired to restore the design intent.

**Structure 1FL-1, arrow showing
breached wall.**

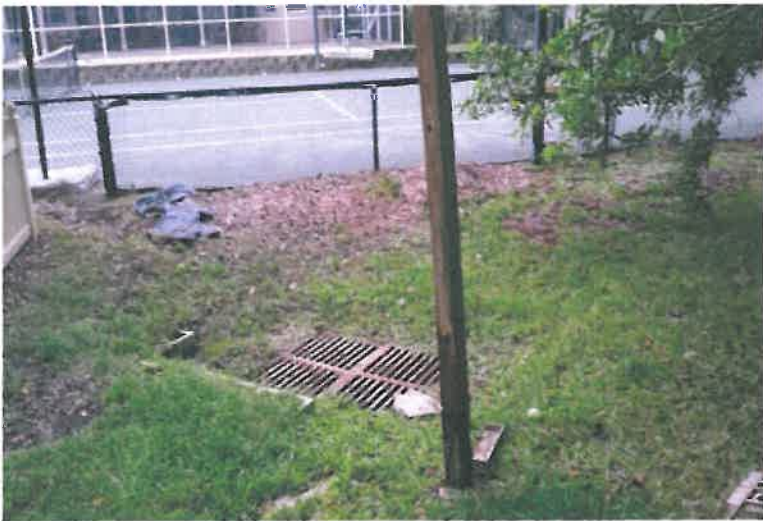
Structure 1FL-3

Continuing downstream of 1FL we encountered additional matters impacting, or potentially impacting, the intended unimpeded drainage flow through the Community. At Structure 1FL-3, a fenced tennis court has been constructed by a private residence over the existing drainage easement for 1FL. This appears to be located on an improved Aberdeen subdivision lot located at 1283 Greybrooke Place. The significance of this is that the recorded drainage easement for Channel 1FL, contains an underground 48 inch pipe, with interconnecting drainage structures in the form of Grate Inlets. The presence of the fenced tennis court certainly will inhibit, or possibly prohibit, access to these structures and pipe systems for maintenance purposes either now or in the future, when such is necessary. Immediately downstream, at Structure 1FL-4, which is a concrete slotted inlet, and discharges collected drainage flow from the drainage easement and Channel 1FL into a retention pond located at North Golf Hole Number 3 tee area. This structure appears to have some residential landscaping covering a good portion of it, likely planted by the occupant of 1276 Greybrooke Place. To maintain the intent of the Structure, this landscaping needs to be removed, as it is obstructing flow out of the structure.

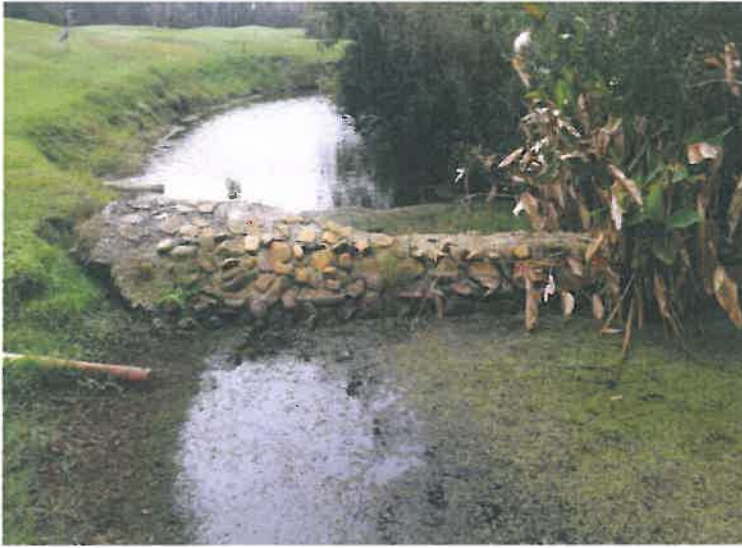
Structure 1FL-6

Continuing downstream adjacent to North Golf Hole 3 Green, is structure 1FL-6, which was originally constructed as a v-shaped horizontal metal weir, and has now completely disintegrated. It is apparent that someone made an attempt to restore this weir as a sand bag and concrete weir. It appears that this sand bag and concrete weir, likely not constructed at the intended design elevation, is being breached by erosion around the structure, and is not serving its' originally designed intent. This weir needs to be restored to the original design elevation and size.

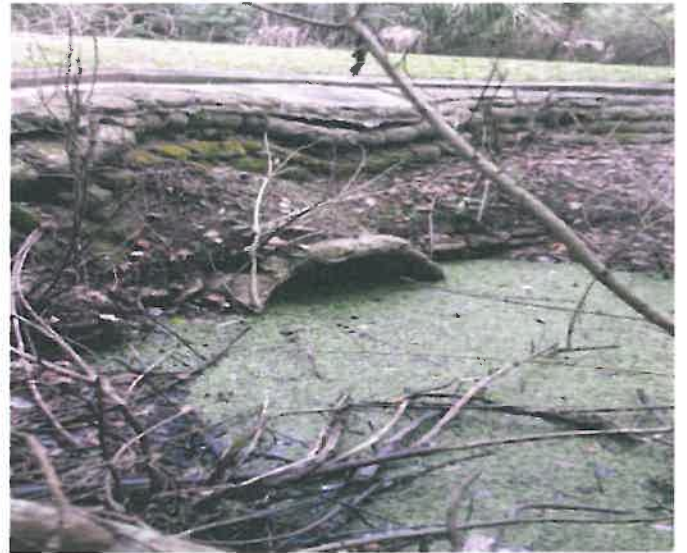
Structure 1FL-7

Proceeding downstream to Structures 1FL-7 and 1FL-8, which convey collected Channel drainage under the cart path just west of Golf Hole 16 Green, cleaning of existing vegetative growth and accumulated sediment around the structures is necessary.

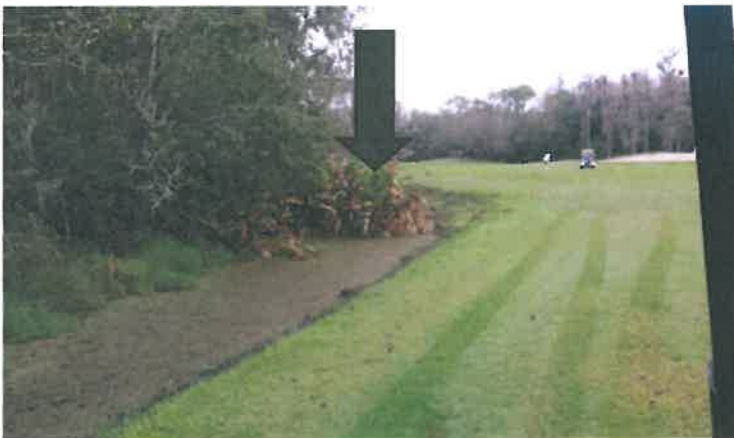
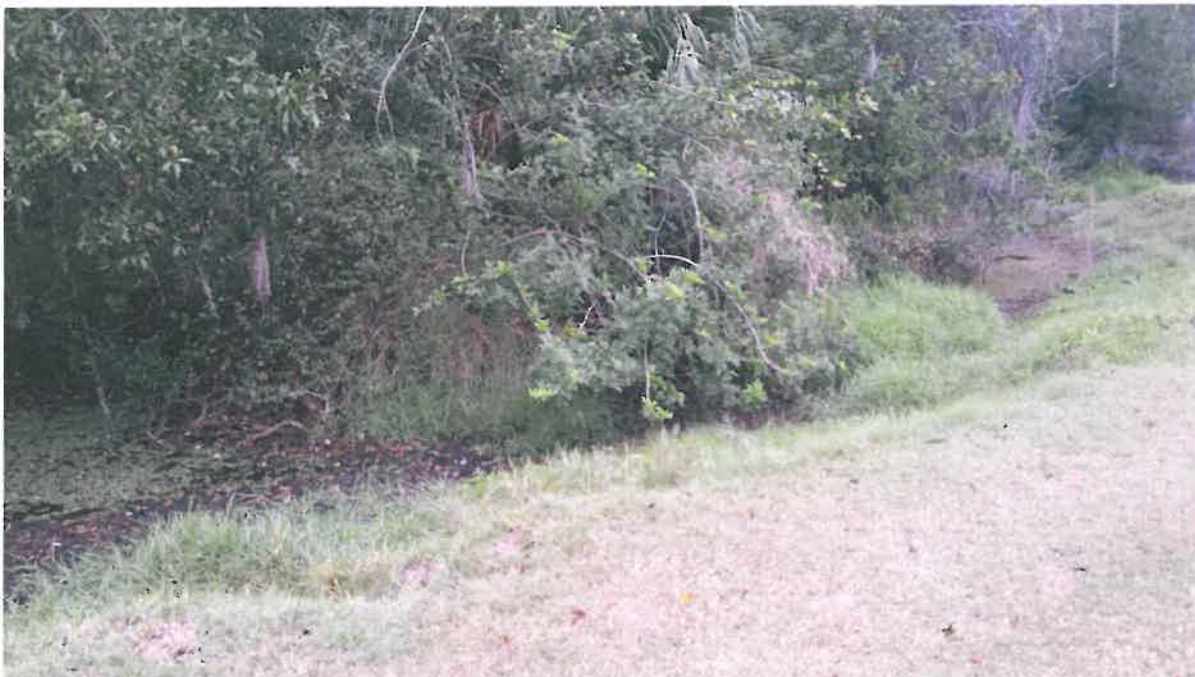
View downstream of structure 1FL-5

Continuing downstream, Structure 1FL-5, which is the outfall for the retention pond at Golf Hole 3 tee, and for the continuation of 1FL drainage, is being partially blocked by sediments and vegetative growth that has apparently accumulated over the years. Additionally, the existing ditch on the west side of North Golf Hole 3 from the tee to the green, has substantial amounts of vegetated growth and sediment, likely blocking its' intended drainage flow capacity. This ditch needs to be cleaned and restored to its' original grades from the tee to the green.

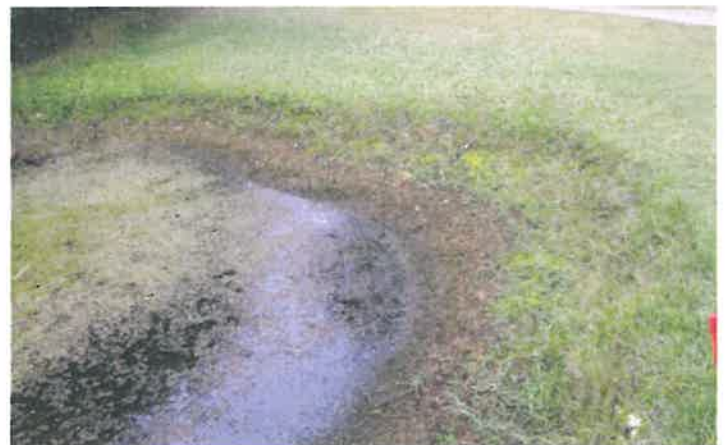
View downstream of structure 1FL-6

At generally the same location immediately downstream, according to the Archived Plans, twin 36 inch pipes are supposed to exist, conveying drainage in the Channel across the cart path just past Golf Hole 3 Green. Neither of these pipes were visible during our inspection, due to accumulated sediment. This area needs to be cleaned of the sediment to uncover the pipes, and insure they are free from blockage. On the north side of the cart path crossing, the discharge end of the 36 inch pipes are barely visible, again obscured and partially blocked by vegetative growth and sediment. Obviously, to insure proper function of the Channel this area needs to be cleaned of the vegetative growth and sediment accumulation.

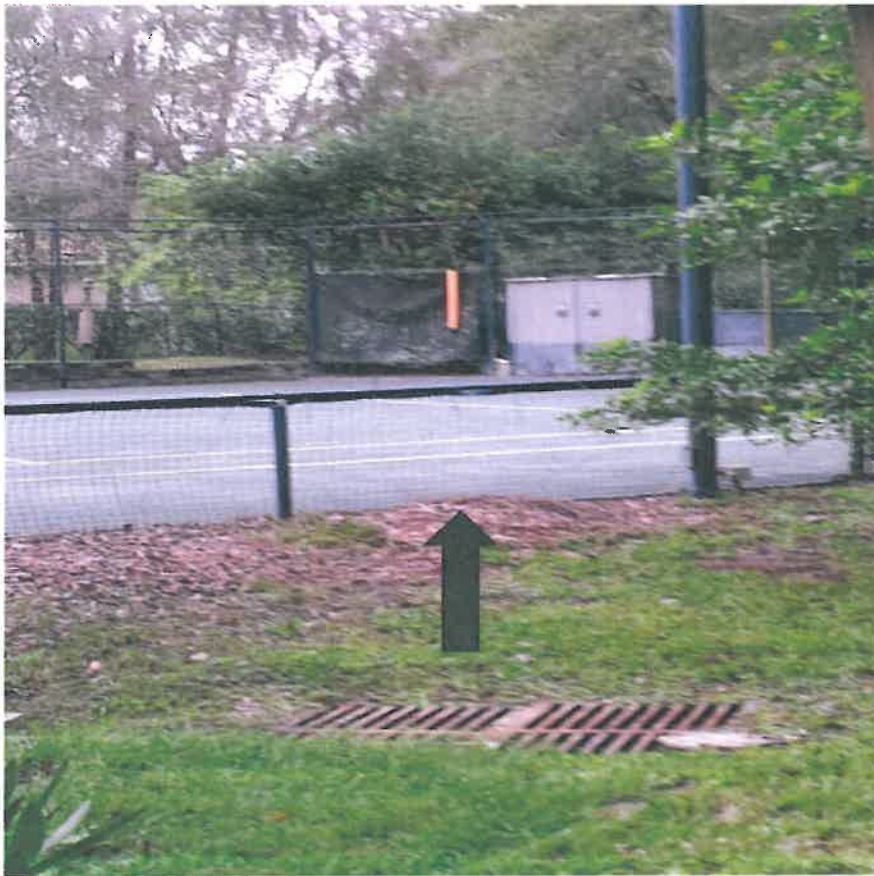
View downstream of structure 1FL-3, arrows shows tennis court drainage easement intrusion

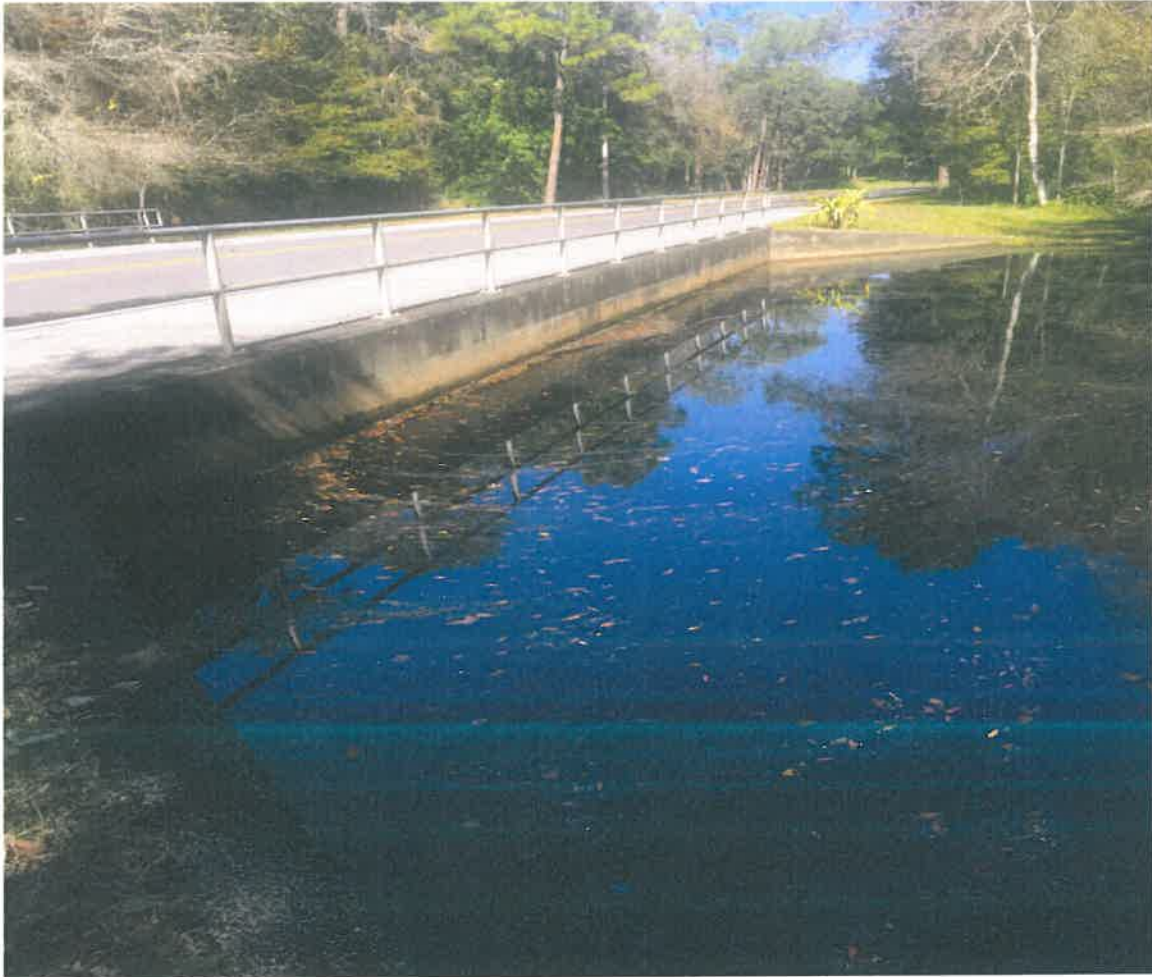
Structure 2FL-1 is a triple box culvert that conveys primarily the offsite drainage from the Forest Lakes Community under East Lake Woodlands Parkway to the riverine drainage system of Channel 2FL. Both the Structure and the riverine system seem to be functioning as intended.

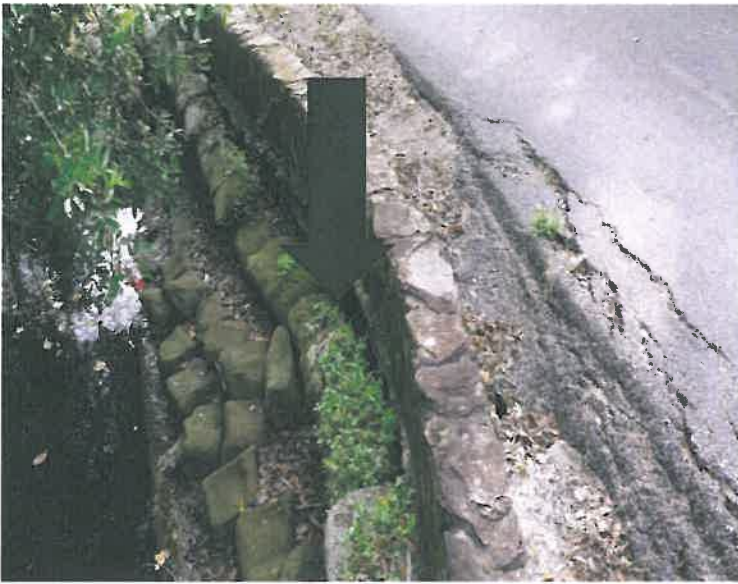
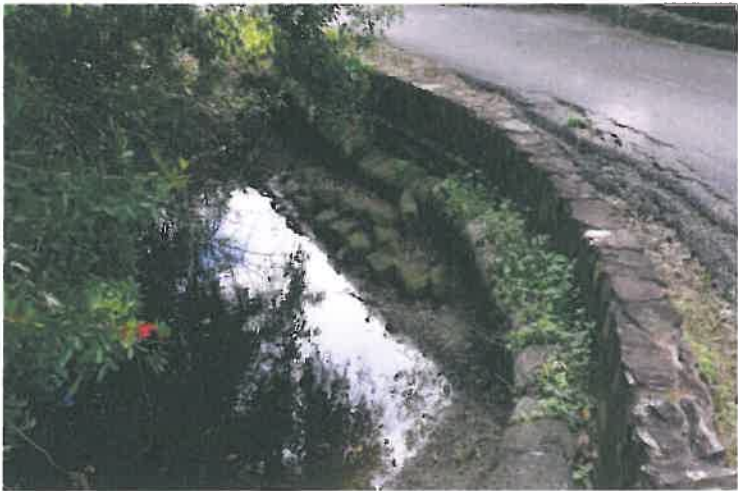
Starting at the upstream point, flows are added to the Channel from the Cross Pointe Subdivision via Structures NGC-1 and NGC-2, which carry the outflow from the Conservation Area east of the Subdivision, and under the cart path just past the Green for Golf Hole 4, via twin 36 inch pipes. Structure NGC-2 is in need of repair as the rip rap headwall is separating and is degrading in integrity. The balance of Channel NGC is, as previously stated, a riverine system; appearing to be functioning adequately, save for Structure NGC-3, which is a triple box culvert structure. The northerly-most box culvert has heavy vegetative growth around it, potentially blocking its' function, and needs to be cleaned.

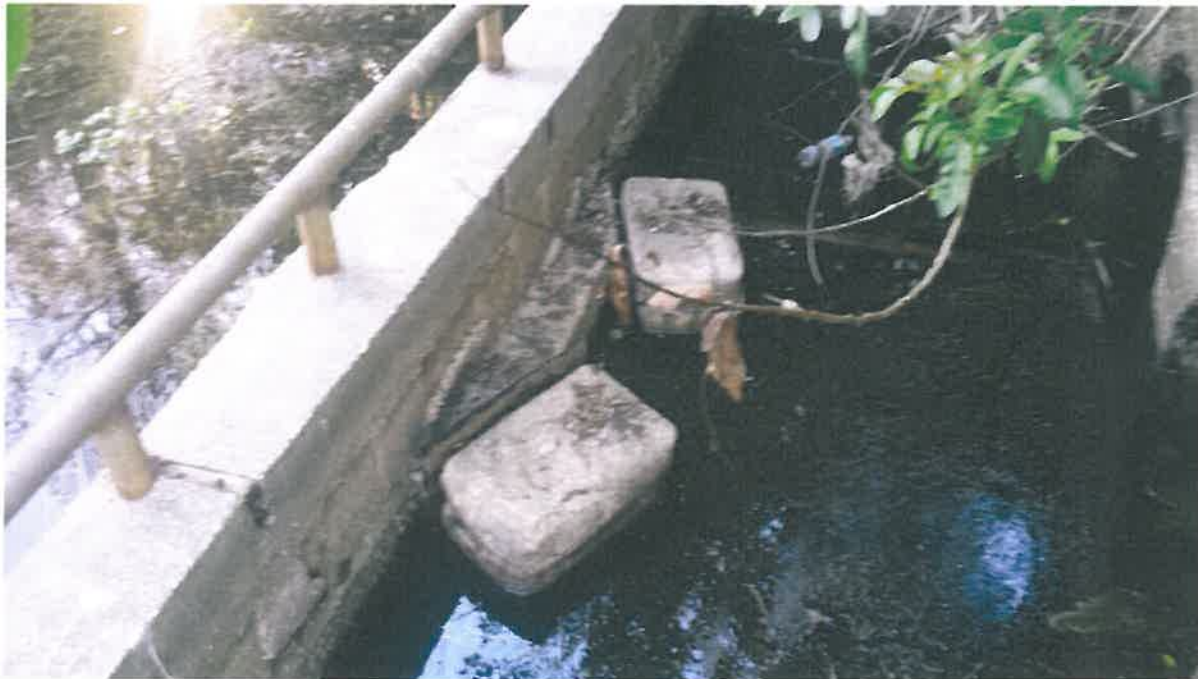
Structure NOF-1

Structure NOF-1, which is a large concrete box weir with triple 48 inch pipe discharges, is in need of substantial repair or replacement. The weir structure itself is breaking apart, and the triple 48 inch pipe which conveys storm water discharge from the Structure under Nursery Road is separated from the concrete box weir structure. This is allowing the weir structure to be by-passed, and the pipes to collect sediment from erosion around the structure. The pipes need to be repaired or replaced, and sediment that has collected around them needs to be removed, both at Structure NOF-1, and at the discharge end of the pipe across Nursery Road.

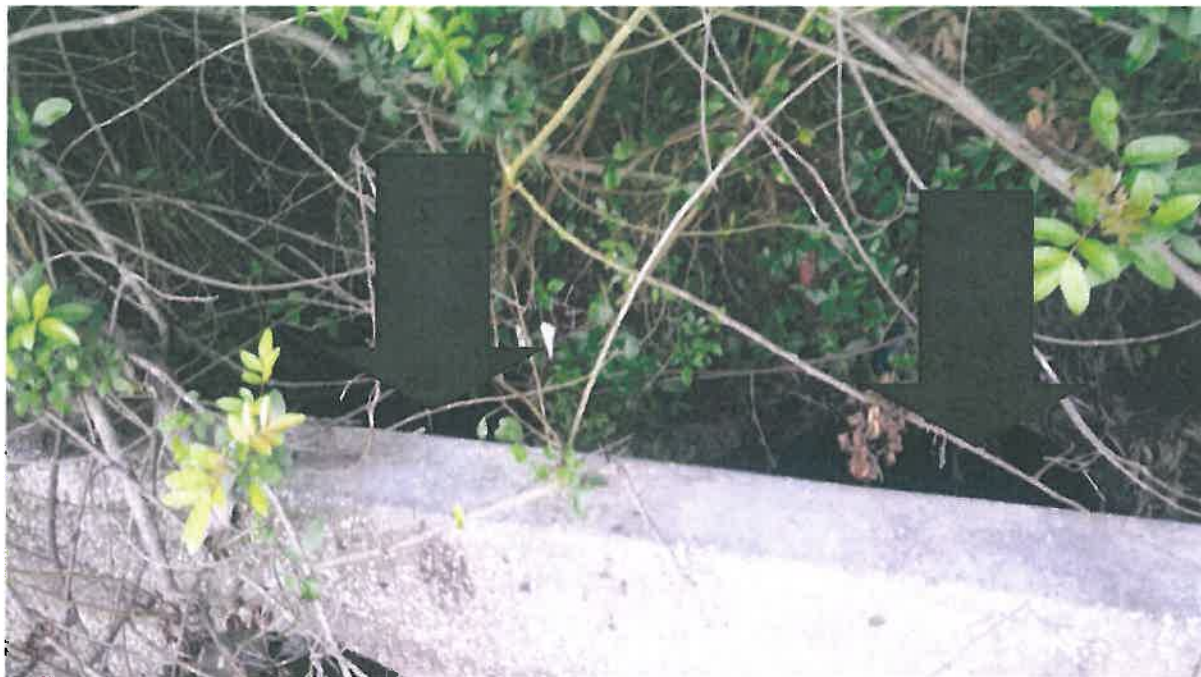
Structure NOF-1, arrows show pipes separation from concrete weir.

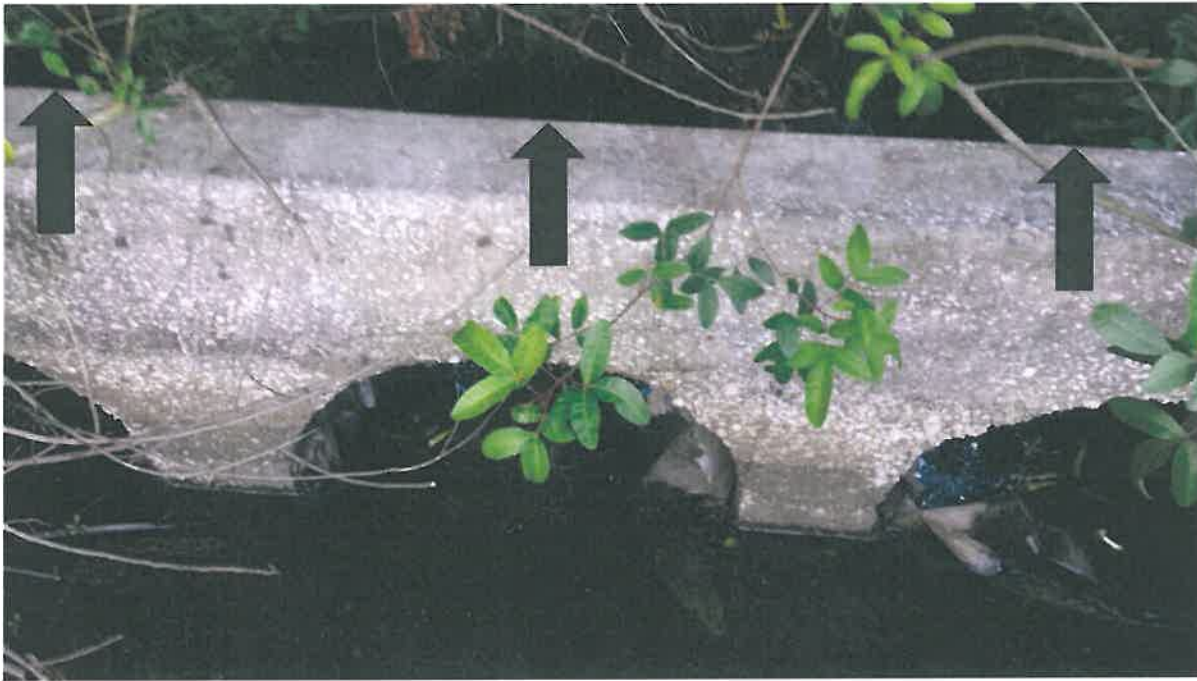
Structure NOF-1, arrows show separation between concrete weir and structure.

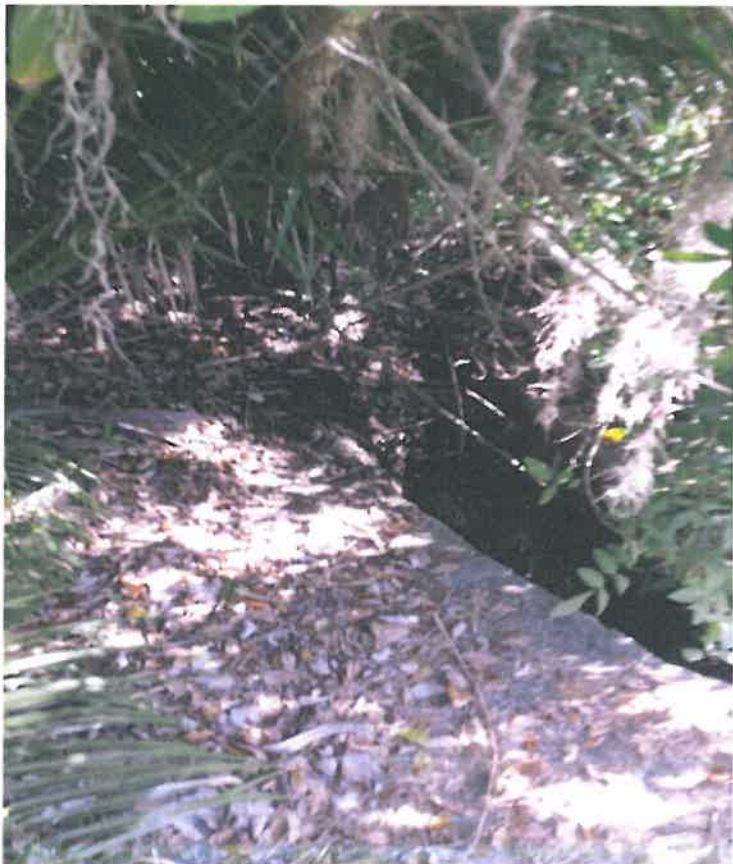
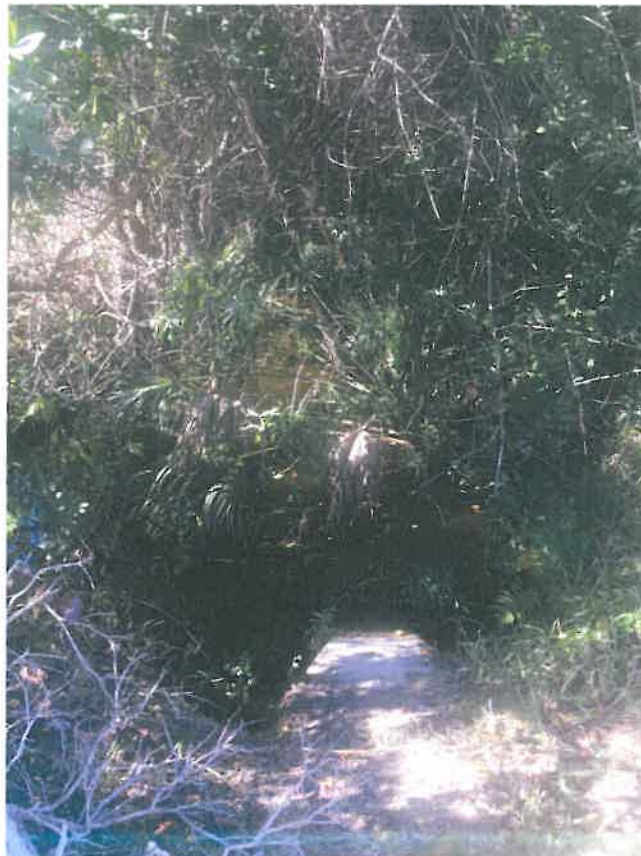
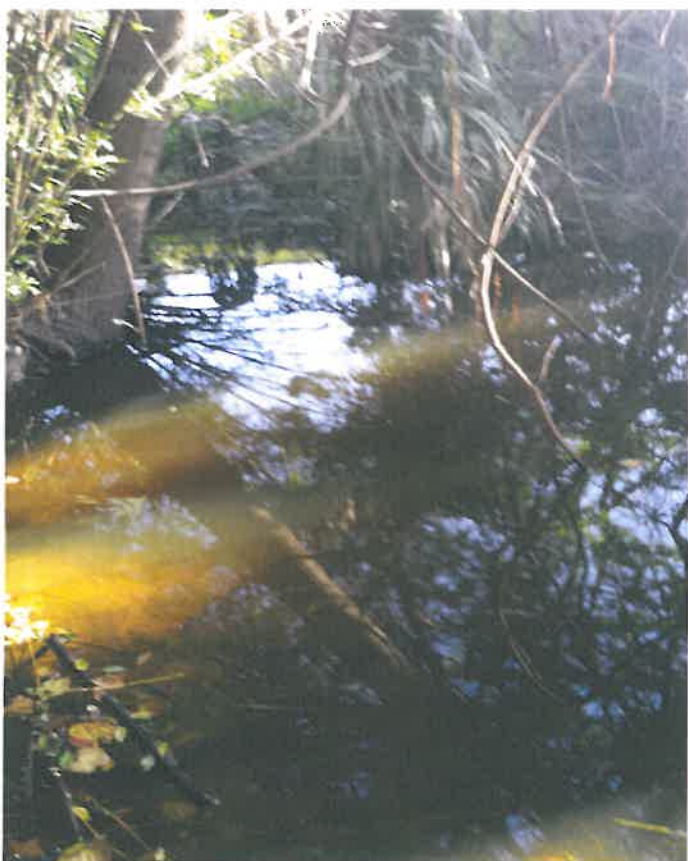
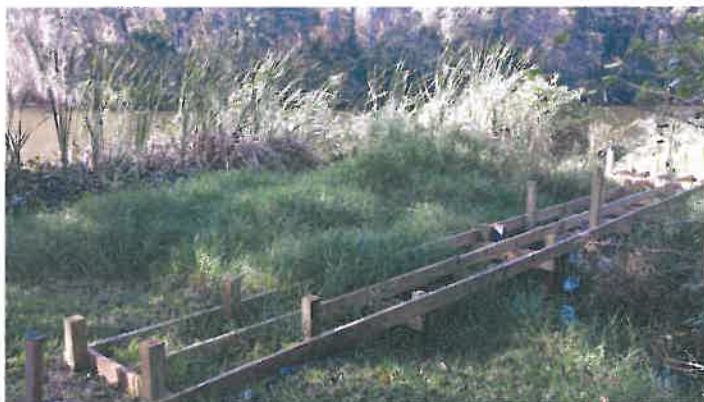
Structure 1AB-1

Channel 1AB is nearly totally blocked with vegetation and accumulated sediment. This blockage has already likely caused a failure in the underdrain system located in the retention pond that collects and stores storm water drainage before discharging into the Channel, and ultimately into Channel EL. This underdrain failure is resultant from higher-than-intended elevations in the lake (approximately 1.5 feet), due to the significant blockage in the Channel 1AB (ditch) outfall. The Channel contains an abundant amount of invasive vegetated growth which greatly impedes the discharge flows from the Aberdeen retention pond, North Golf Hole 17, and Woodlands Boulevard. The outfall ditch needs to be substantially cleaned so that the system can perform as designed, and to prevent the ditch flows from becoming completely blocked. Also, at the very westerly end of Channel 1AB, near its' intersection and outfall into Channel EL, it appears that a Preserve Subdivision resident, with a street address of 1276 Preservation Way, is constructing a dock directly over the drainage outfall and drainage easement. This dock, if not removed, will likely inhibit the proper cleaning, and necessary regular maintenance, of the Channel outfall ditch.

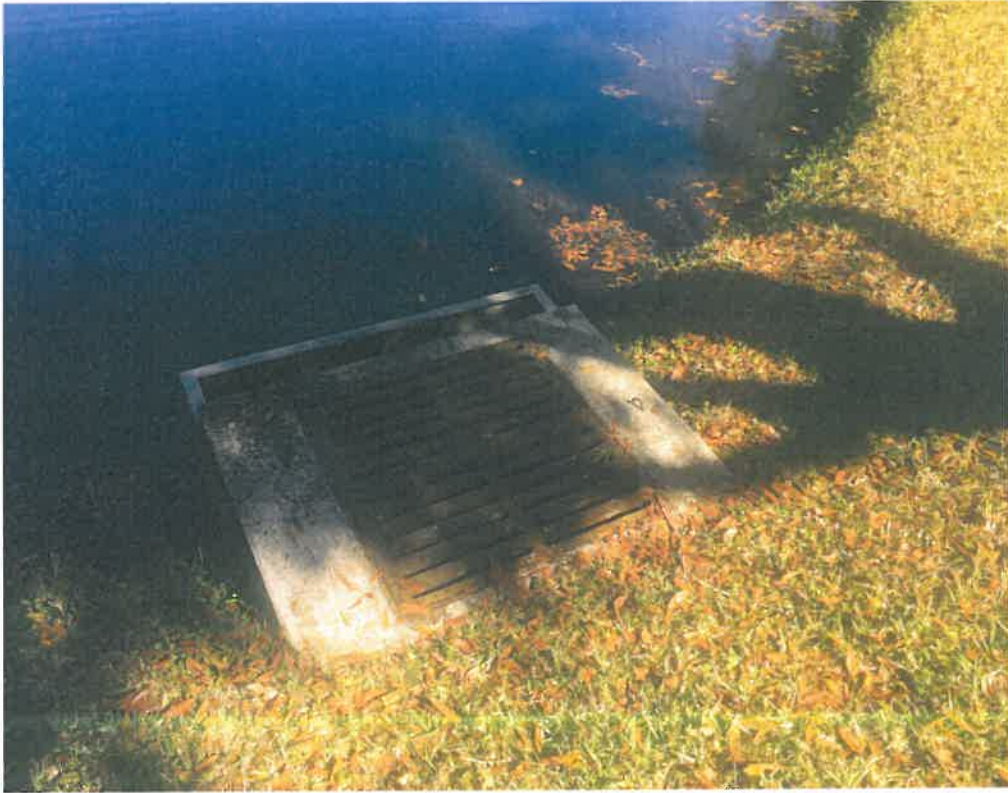
Structure 2AB-1

Channel 2AB commences at the retention pond located in the Heatherwood Condominium development. A concrete weir, structure 2AB-1, controls the outflow from the retention pond, and pipes convey the outfall from the weir southwardly across East Lake Woodlands Parkway, through Silverthorne, and into the retention pond system located north of North Golf Hole 1.

The Channel and its' structures appear to be functioning as intended. It is worth noting however, that the underdrain in the Heatherwood Condominium retention pond is disconnected from the concrete weir outfall, and located on the bottom of the retention pond lake bank, and not functioning as intended.

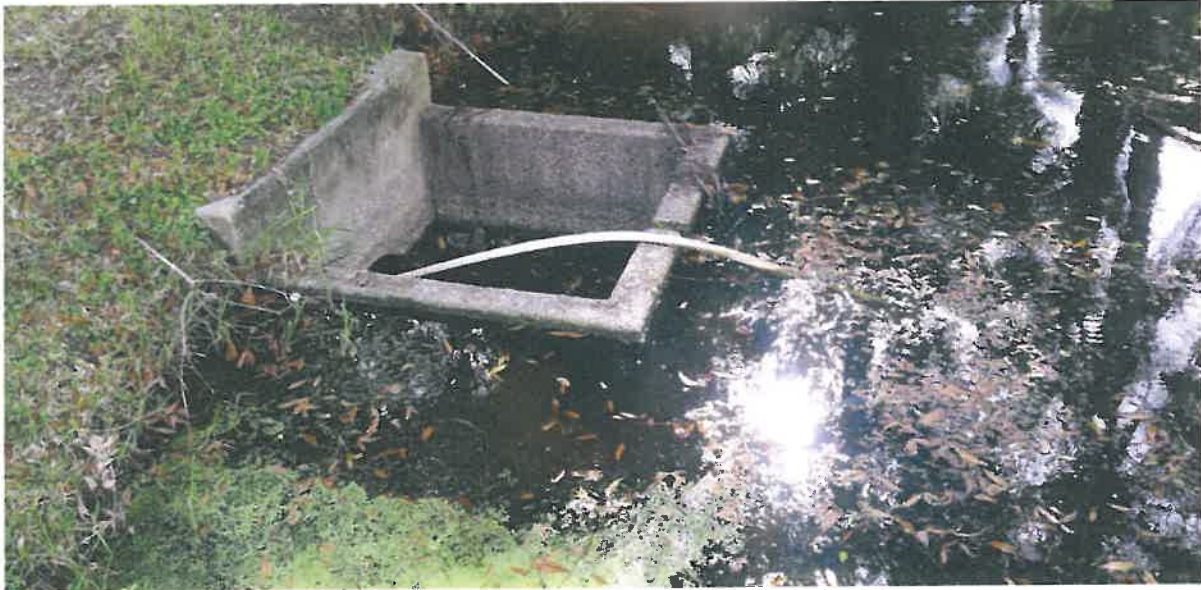
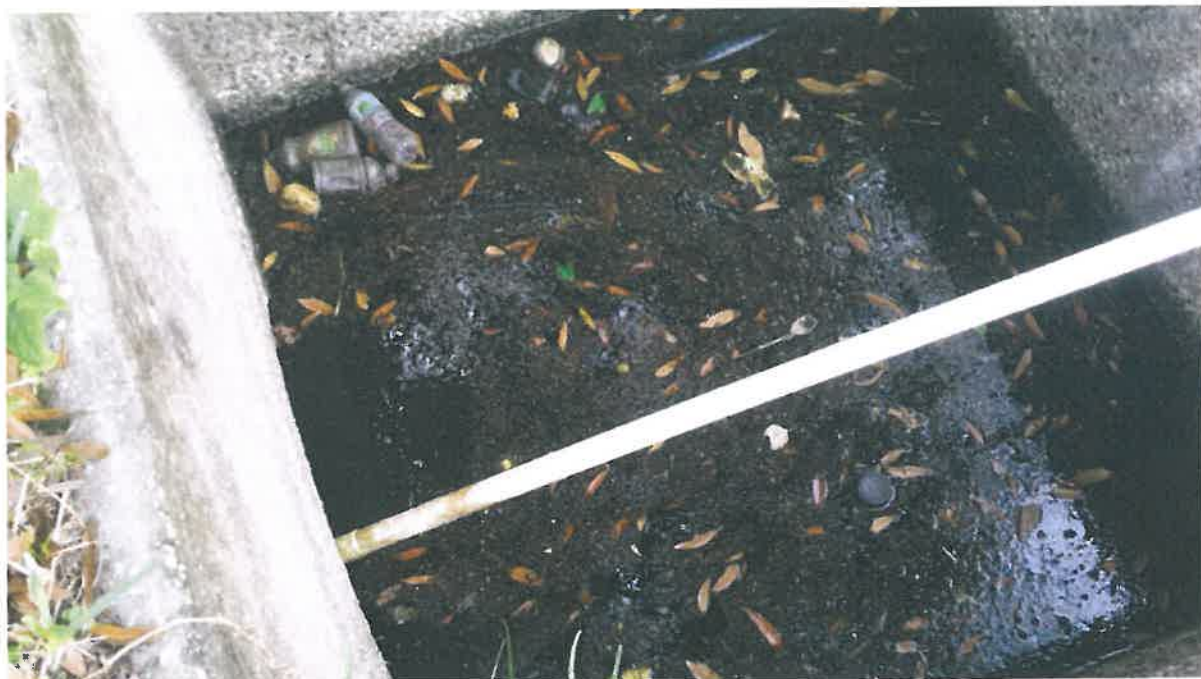
Structure EL-1

Further downstream, a concrete weir structure, Structure EL-1, is partially blocked by debris, and has a grate inlet top missing from the Structure. This should be cleaned out of all existing debris inside of the structure, and have a grate reinstalled.

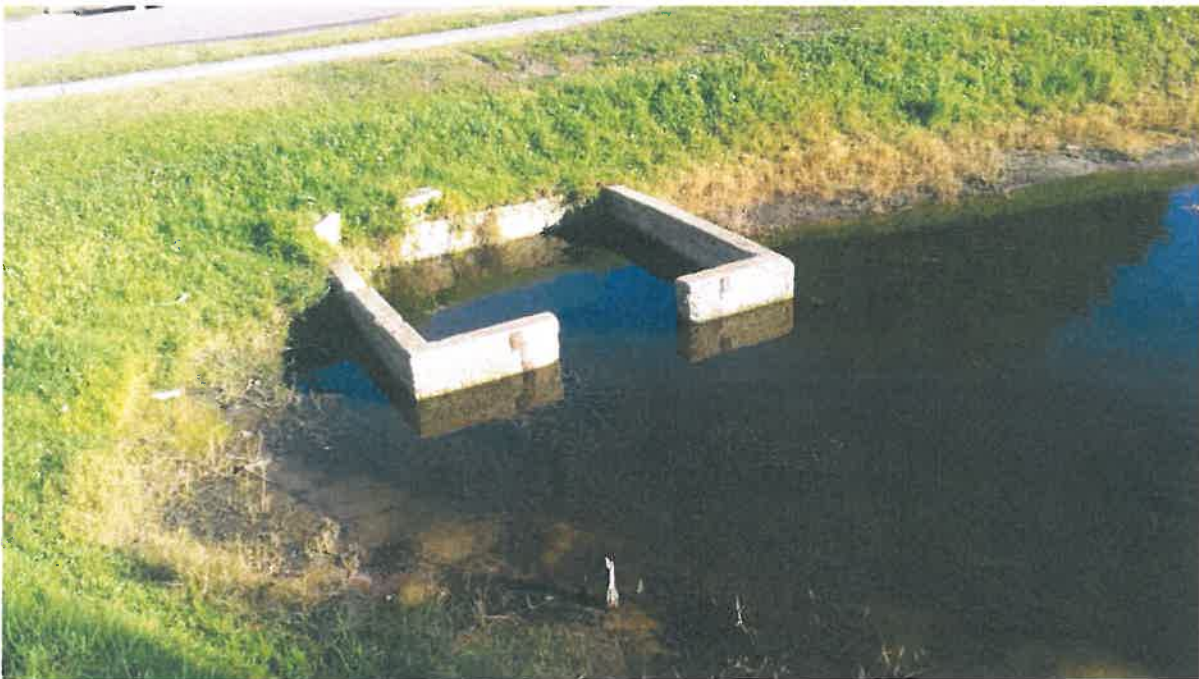
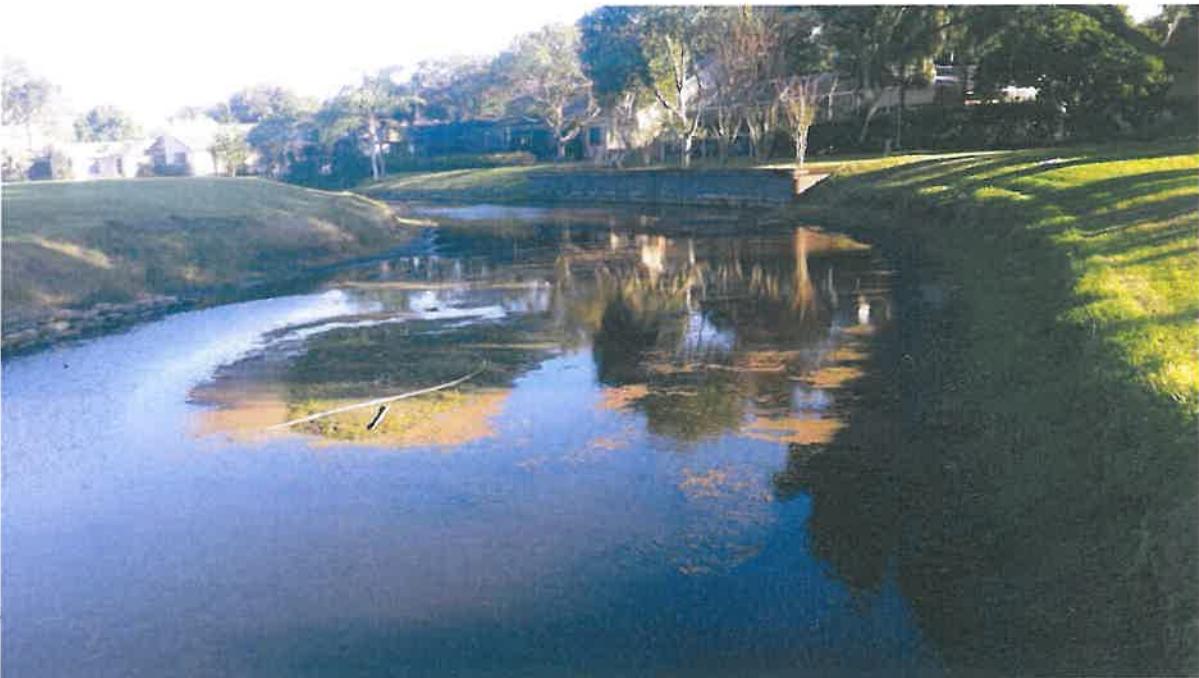
Structure EL-2

Proceeding further downstream, Structure EL-2, again a concrete weir structure, appears to have been modified from its' original design. Part of the structure appears to be missing, preventing the weir from controlling the normal water elevation in the upstream lakes. Again, this is not necessarily of concern from a drainage standpoint, but the lower lake levels again are aesthetically unpleasing, and allow for lake bank erosion of the upstream retention ponds, and are a sediment source which could limit the capacity of downstream drainage facilities. This sediment source is noted in the downstream retention pond immediately across Forest Park Road. Both the concrete weir and the sediment in the downstream retention pond should be restored as originally intended.

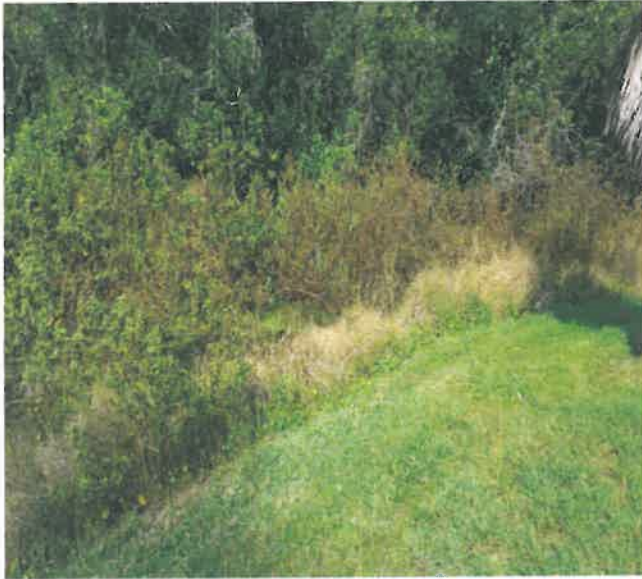
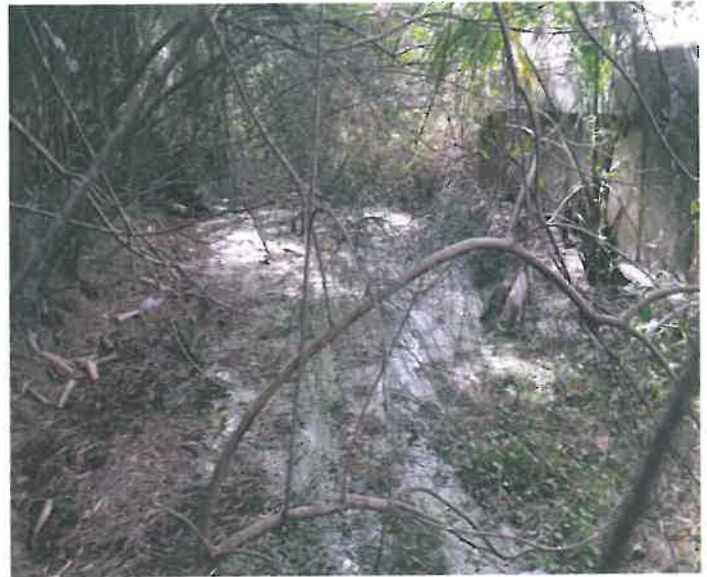
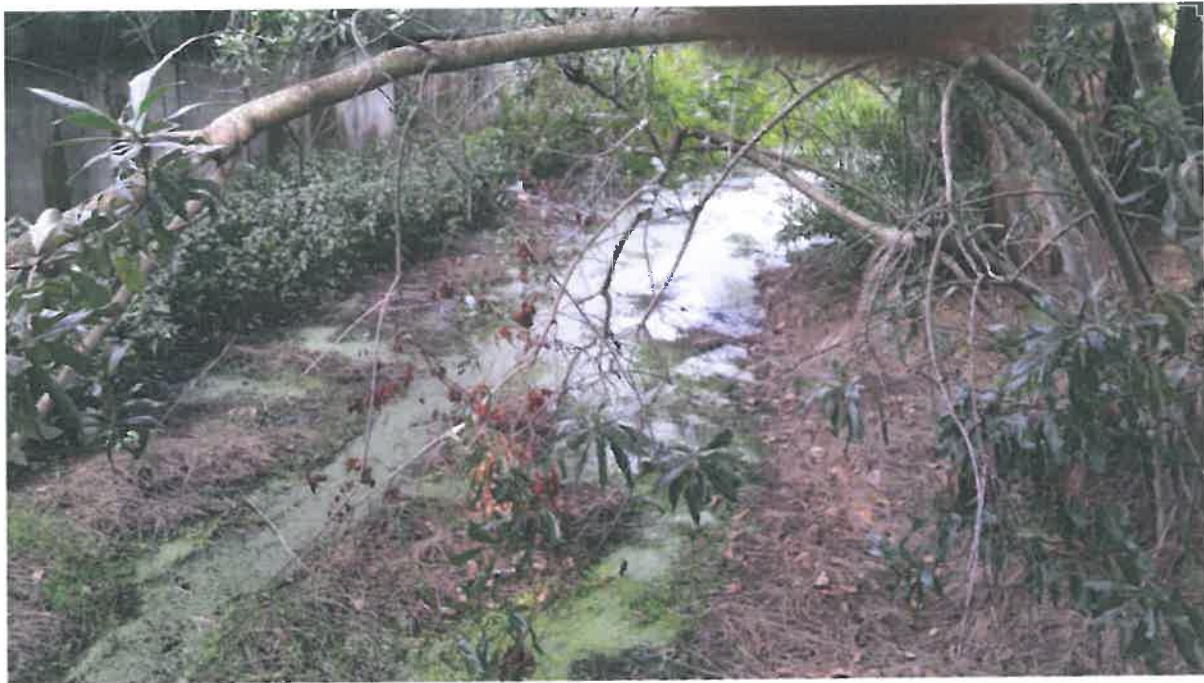
View of channel EL near Palmdale Drive

Starting at the most upstream point of the Channel, a narrow ditch system exists that conveys the drainage runoff starting at Arbor Lane, collecting runoff from Palmdale Court, and continuing behind and on the westerly side of the lots on Ivy Terrace and Fernbrook Court. The Channel has accumulated sediment and vegetation partially blocking its' drainage flow capacity. The sediment and vegetation needs to be cleaned, and the Channel restored to its' original grades to insure adequate flow capacity.
