Investigative Report on ELW Master Drainage for the Community Association

Introduction

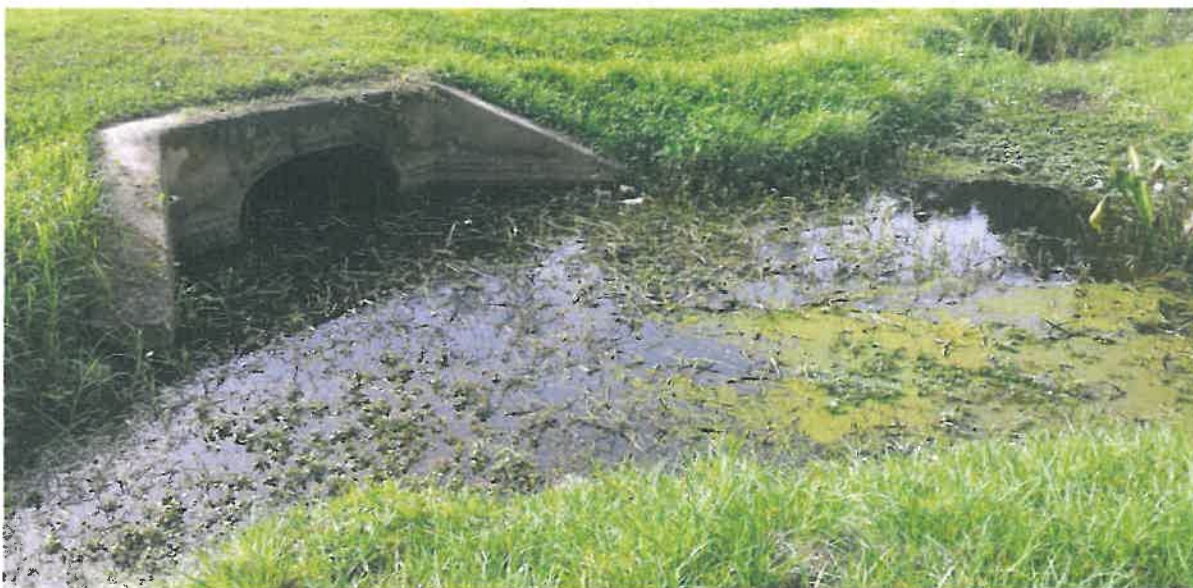
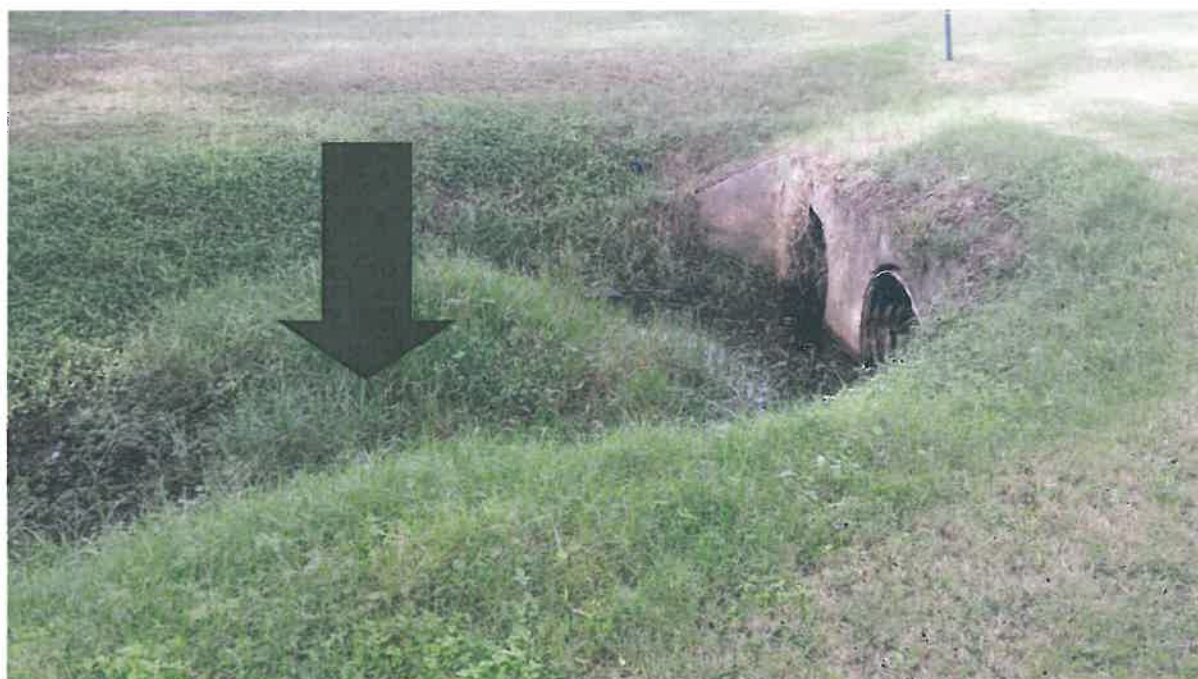
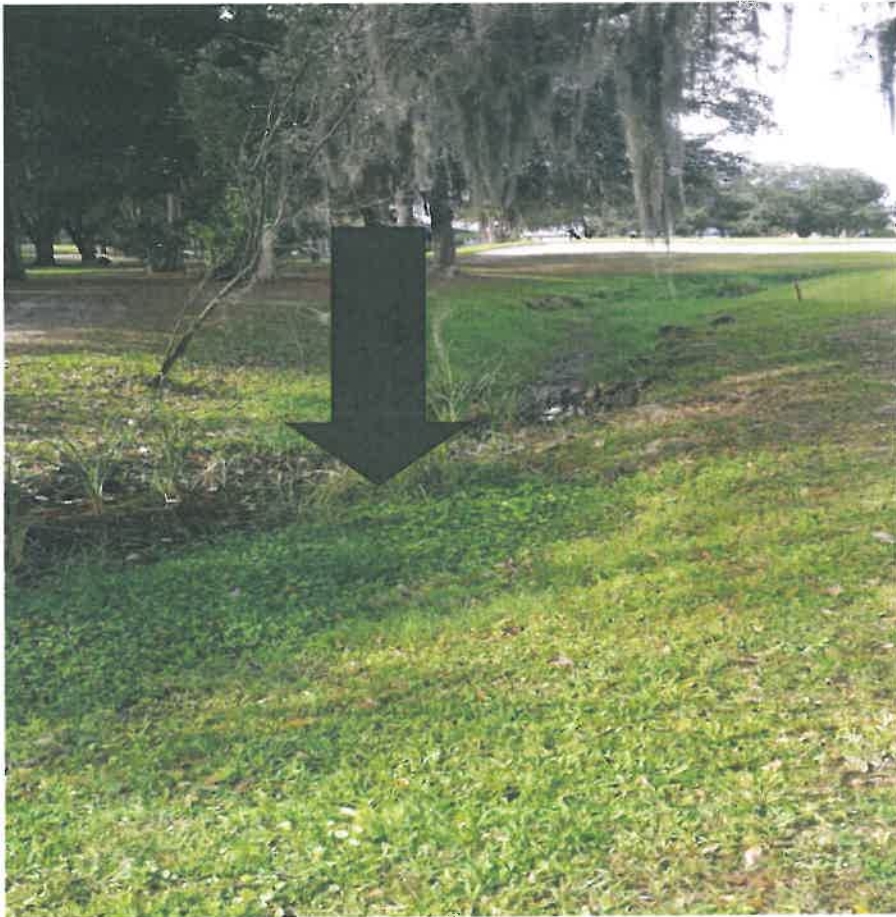
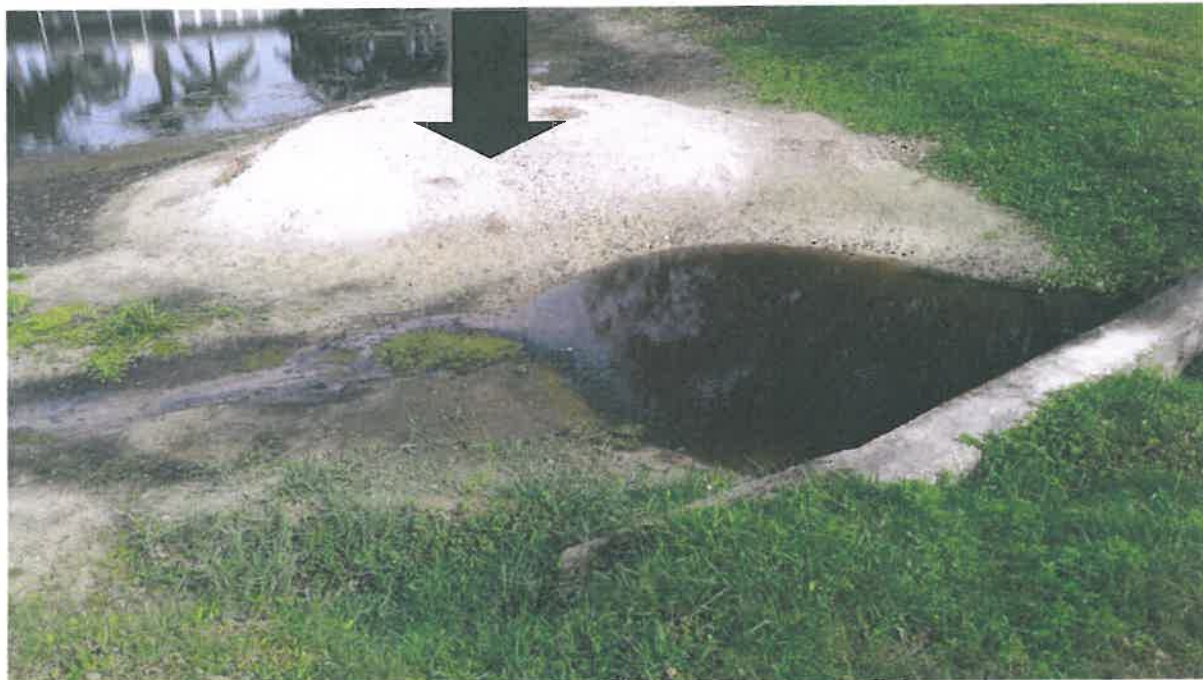
The Channel is in need of cleaning of accumulated sediments and vegetation near structures CT-1, CT-2 and CT-3, and a sizeable sediment accumulation in the retention pond north of South Golf Hole 1, all of which need to be removed and the original grades restored.

Spoil embankment directly downstream of structure CT-4

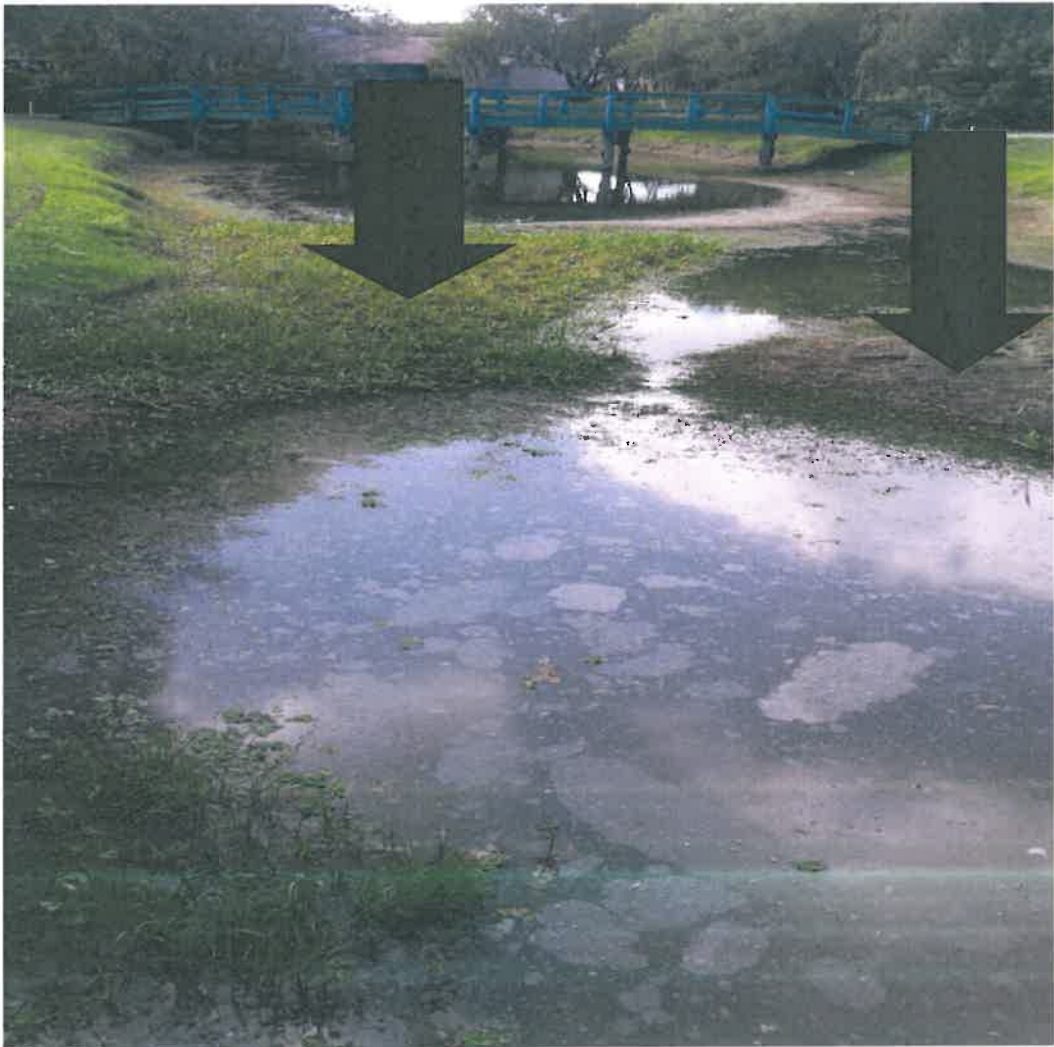
View downstream of structure SOF-1

Channel SOF has sediment accumulated in it immediately downstream of Structure SOF-1. This sediment needs to be removed from the Channel to allow its' intended function.

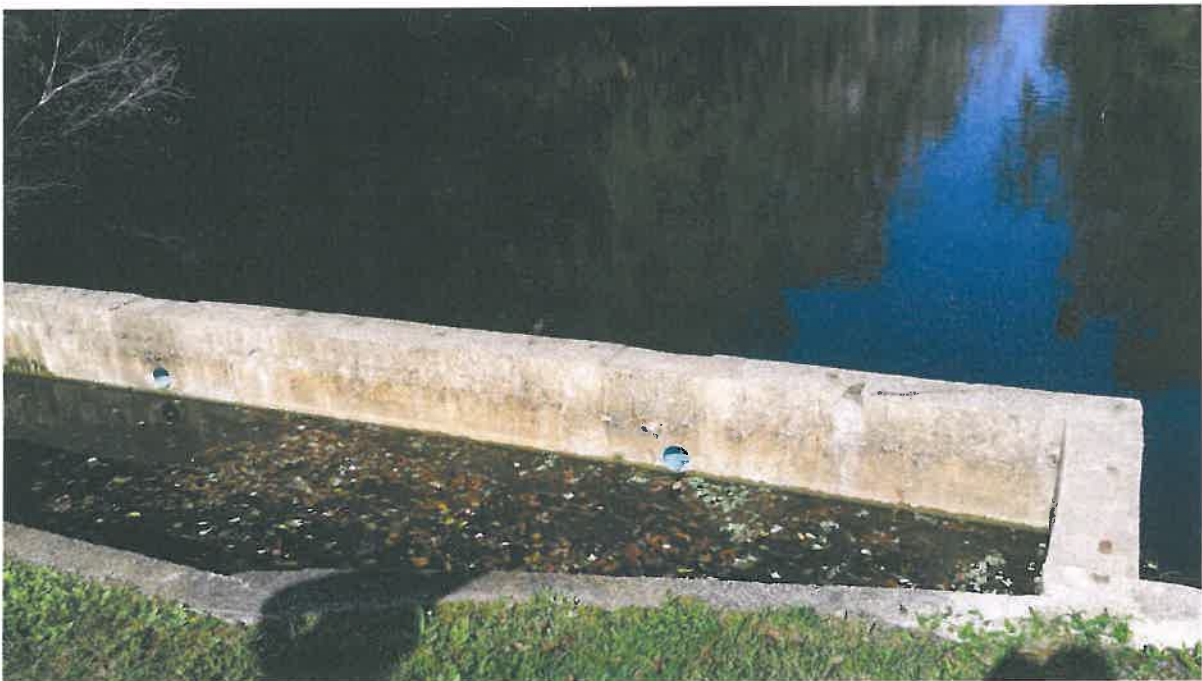
Additionally, at Structure SOF-2, which is the most downstream structure before discharge into Moccasin Creek, it appears that substantial modifications have been made to the structure, most likely for purposes of maintaining a higher water level in the retention pond system that is the primary conveyance system for Channel SOF. From the Archived Plans, it was determined that the desired normal water level in the retention ponds located north of Structure SOF-2, was 2.79. The existing water elevation that was observed during our investigation was more than 1.5 feet higher than this elevation. The original design water elevation at Structure SOF-2 was maintained by original construction of a slotted concrete weir structure. It appears that the slots of the structure, which were two rectangular openings in the weir designed to sustain the normal retention pond water level at a given elevation, have been modified to eliminate them. This likely was done, for purposes of raising the water level in the retention pond, most probably during the drier seasons of the year. In their place, two small pvc pipes (approximately 4 inches in diameter), were installed, and the slots were concreted to eliminate them, and hence, their function. During our investigation, both of these pvc pipes had plugs in them, totally preventing any flow from them. The net result of this modification from a drainage prospective is that storm water flows will be retained, rather than discharged, at higher elevations in the retention pond system functioning as Channel SOF, and these storm water flows will not begin to flow to the Moccasin Creek Outfall until the water levels reach the top of the weir, which is 18 inches higher than the slots. This obviously was not the original design intent, and could impact resultant flood elevations in upstream impacted areas during significant rainfall events. From a drainage prospective, this is not recommended, and this structure should be modified to function in accordance with the original design.

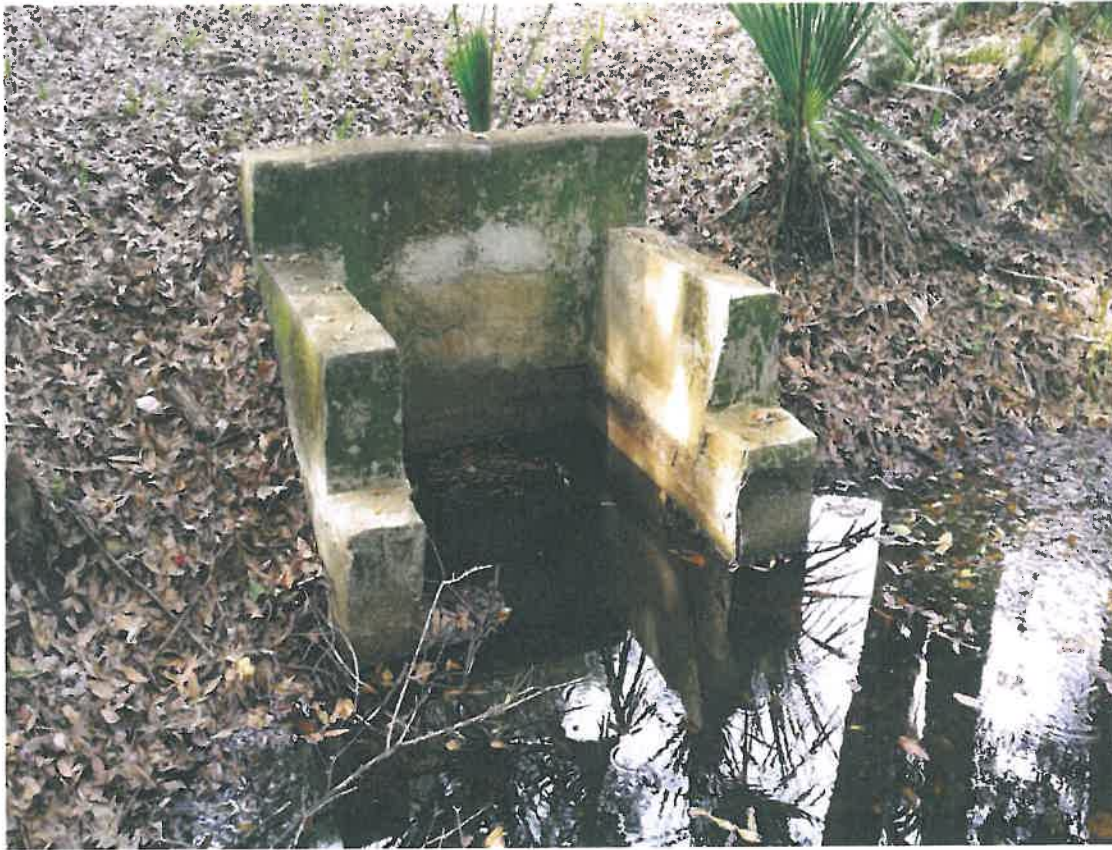
The concrete weir Structure WL-1 is the outfall structure of the Woods Landing retention pond and appears not to be in its' original condition, as its' grate is missing and at least one wall of the structure is gone. This is of a safety concern, and allows the water level of the retention pond to exist at an elevation lower than intended, which was found to be approximately a half of a foot during our investigation. This weir needs to be repaired and restored to its original design.

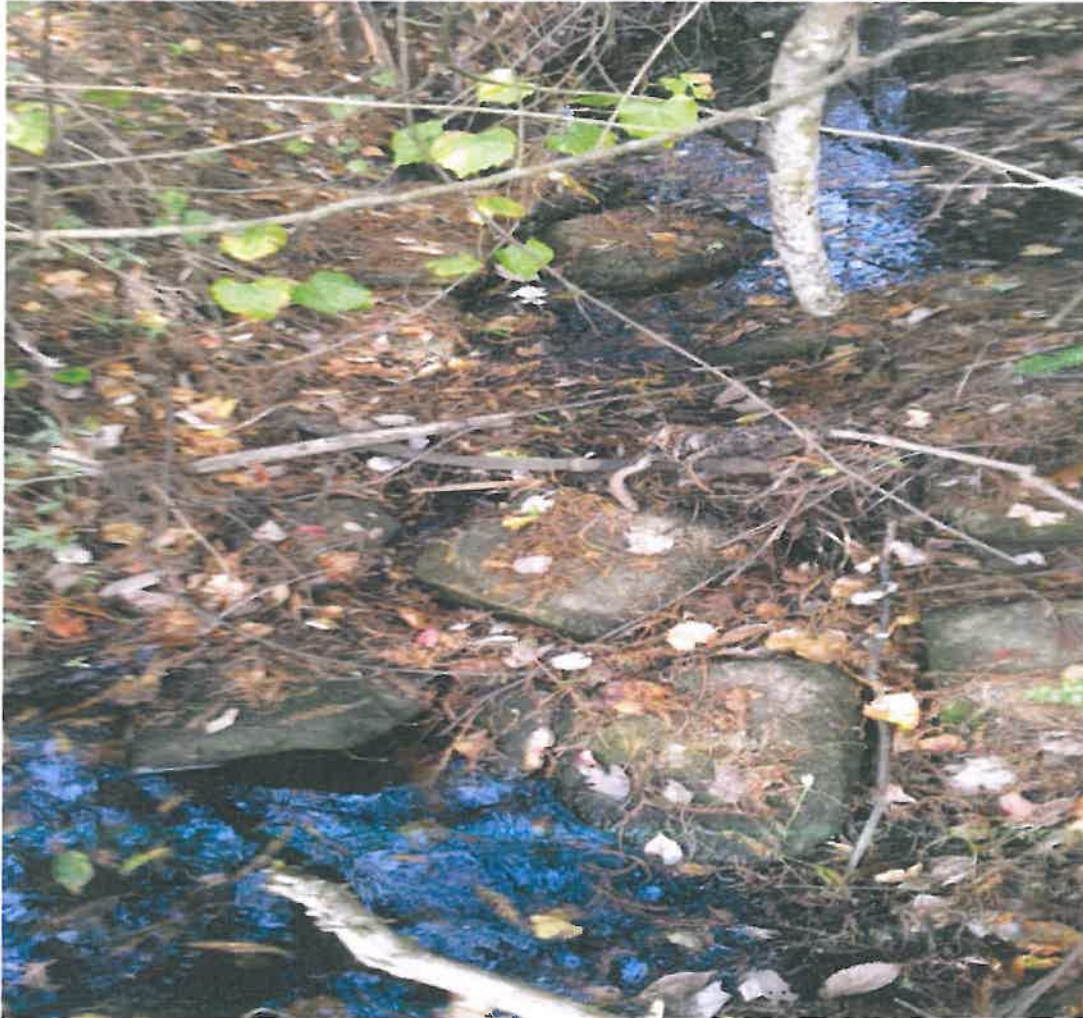
Channel WL looking upstream of structure WL-3

Continuing downstream on Channel WL, at Structure WL-3, is a stone riprap weir, which serves as the outfall structure for Channel discharge into Channel SOF. Immediately upstream of the Structure, the drainage ditch leading up to the Structure is partially blocked with sediment and other debris that need to be cleared. Additionally, the inside of the aforementioned weir, needs to be cleaned of the vegetative and riprap debris that have settled inside of the weir. Flows from the structure cross Golf Hole 10 via twin 36" pipes underneath the Golf Course, prior to discharge into Channel SOF. The headwall, structure WL-4, and discharge ditch of these pipes is partially blocked with sediments that have accumulated, which needs to be cleared and maintained to insure unimpeded outfall flow.

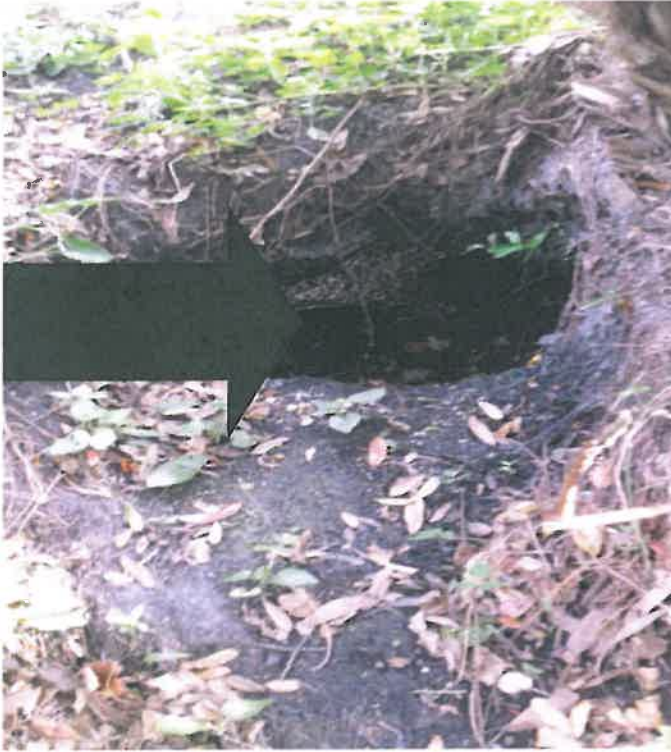
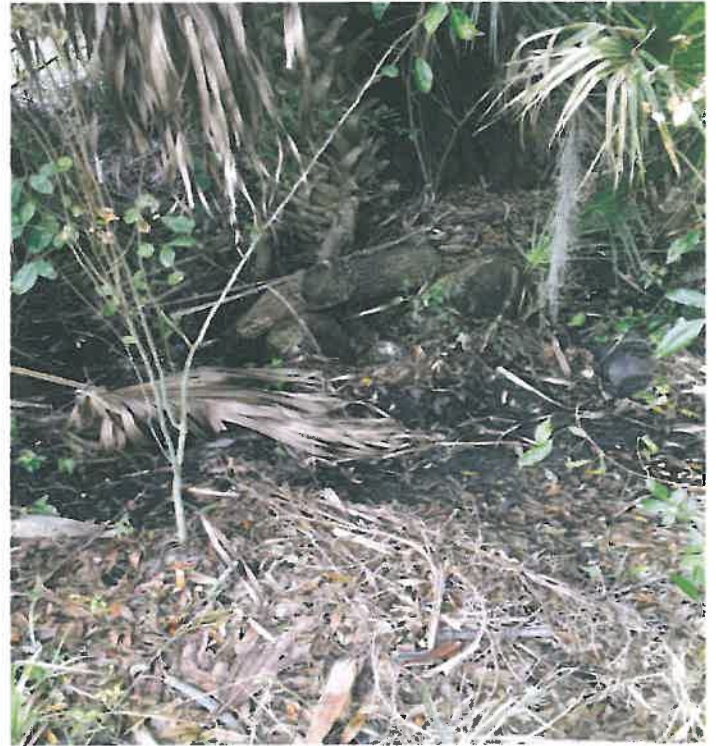
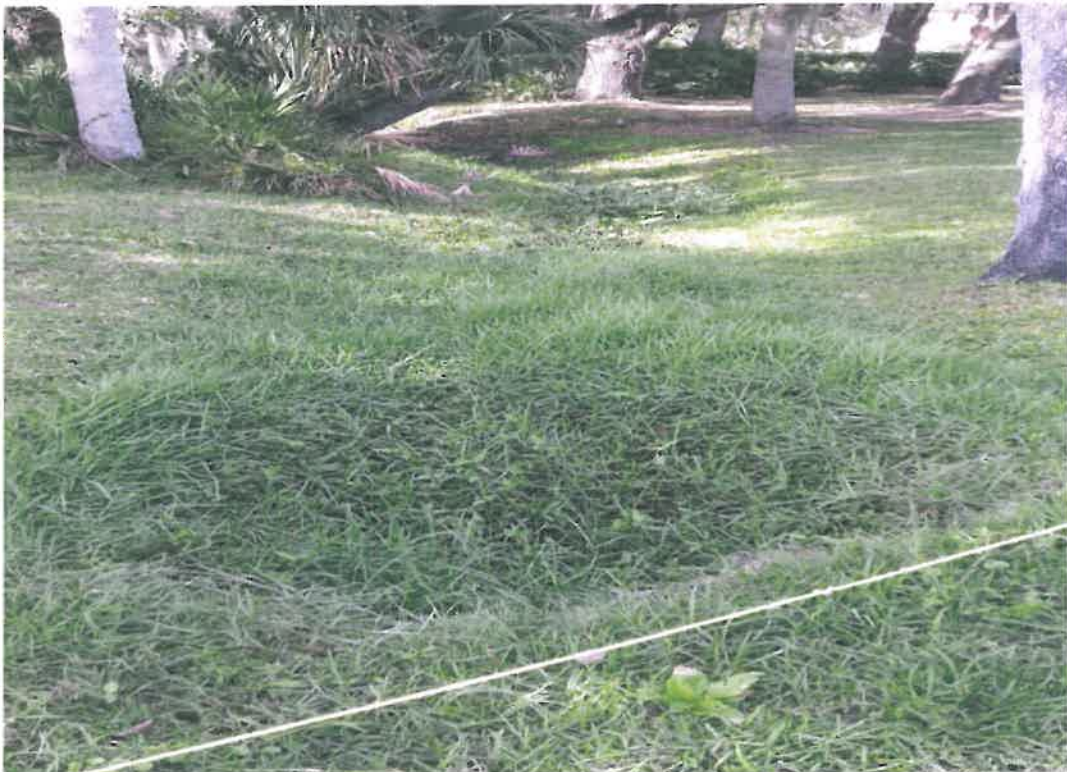
The Channel begins at Structure 2SU-1, a headwall and pipe outfall located just east of Kingsmill at Sunflower Drive. Structure 2SU-1 was observed to be almost totally buried under sediments and vegetation which greatly restrict its' intended discharge. The headwall needs to be cleared of its obstructions. The discharge from the headwall then flows into a ditch/pipe system which conveys Channel drainage under South Golf Hole 12. The ditch is also in need of clearing, as upon visual inspection it was filled with what seemed to be sawed tree limbs and overgrown vegetation that would greatly impede flow conveyance. Further downstream on the discharge end of the ditch, headwalls on both ends of the pipe under the Golf Course, identified as Structure 2SU-2 and 2SU-3, also need to be cleared and cleaned.

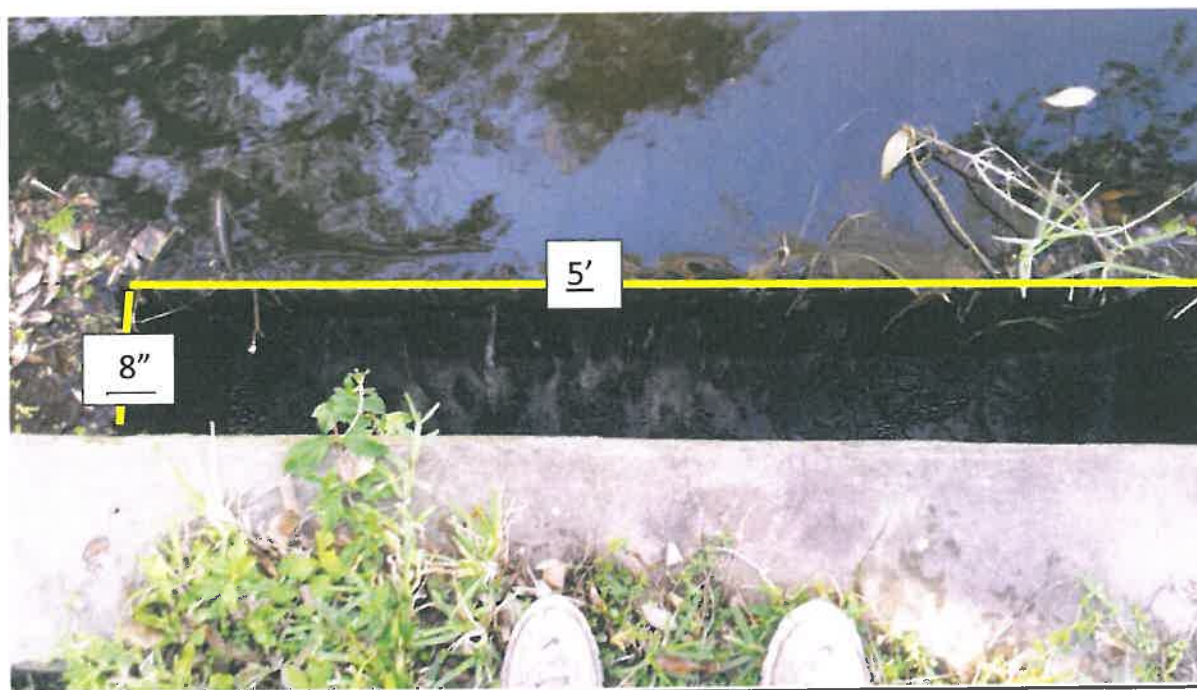
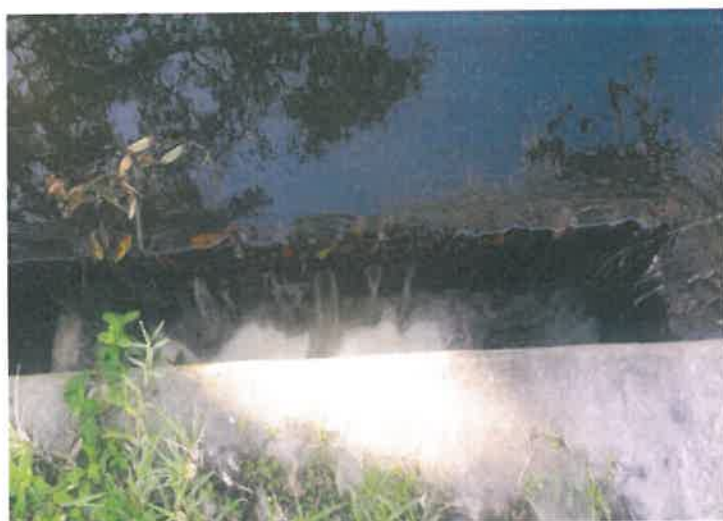
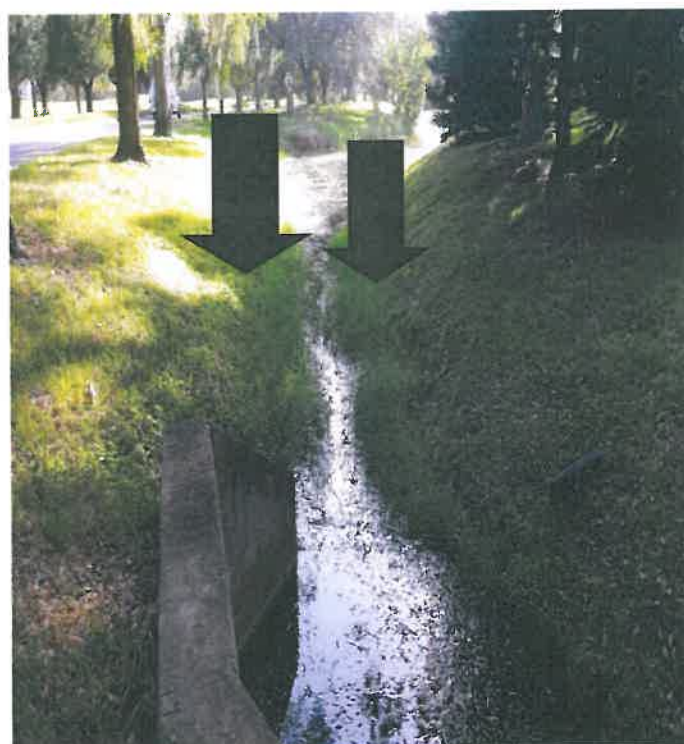
Structure C-1

The ditch system directly upstream of structure C-1 is in need of cleaning of accumulated sediment to insure unimpeded flow from the retention pond to downstream receiving bodies.

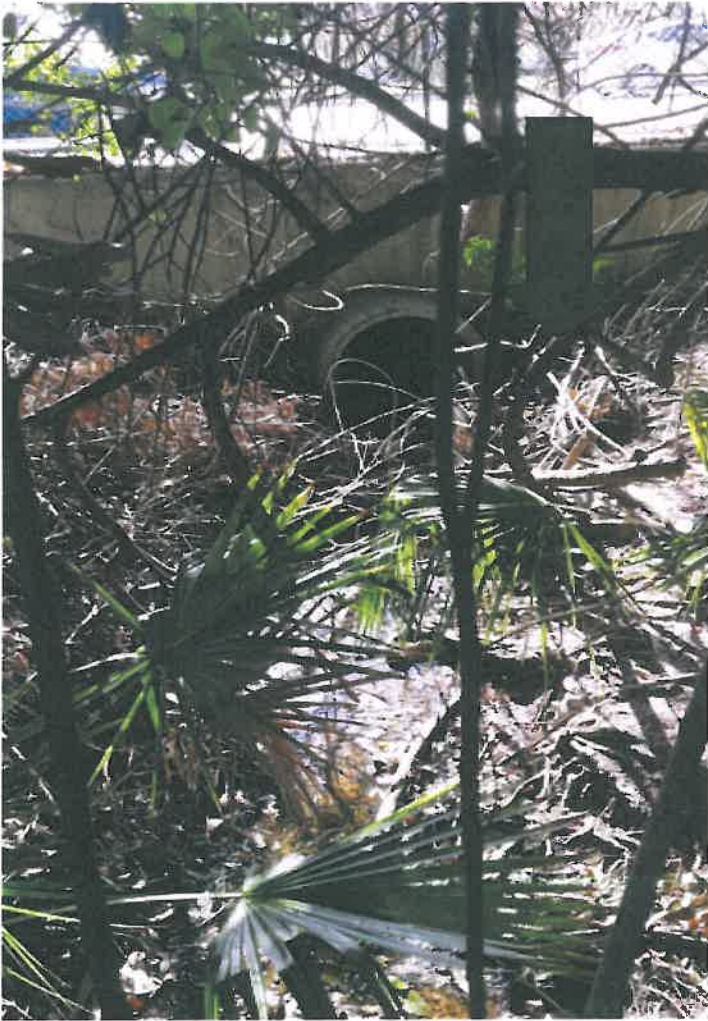
The discharge immediately downstream of Structure WSP-1, which is a headwall for the discharge pipe under S.R. 584, is partially obstructed by invasive vegetative growth, and needs to be maintained.

Structure WSP-1, arrow indicates vegetative flow impediments

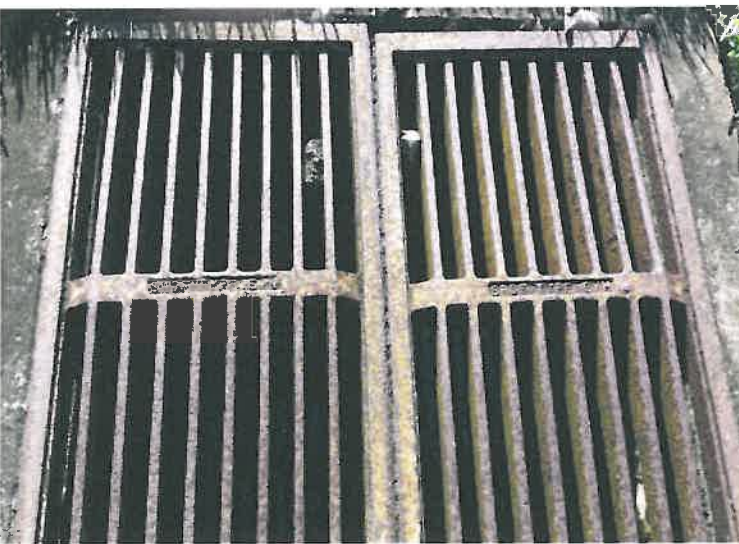
At Structure WSP-2, a grate inlet located within Cluster 4, the grates on top of the inlet appear to be upside down. The inlet needs to have its grates flipped to the correct side.

Structure WSP-2, grate on the wrong way
