DRAINAGE SYSTEM MAINTENANCE INSPECTION REPORT

Date:	October 16, 2018	Inspection #2
Client:	EAST LAKE WOODLANDS COMMUNITY ASSOCIATION	
Attended by:	Drainage Committee-Jack Picker, Jeff Fosbrook AMI-Cary Williams PSA-Tom Picciano

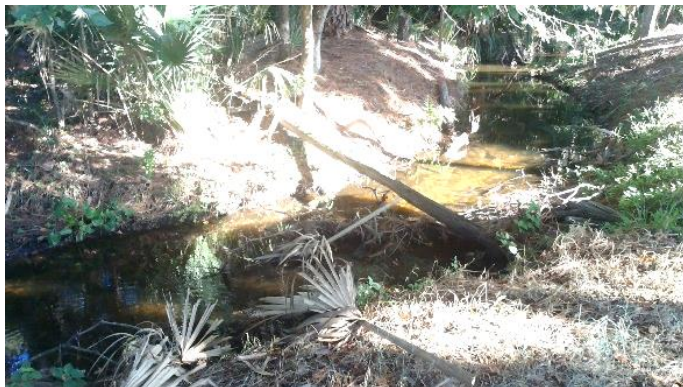
1) Beaver Creek running along #8 north fairway-remove logs and palms fronds. **\$795.00**

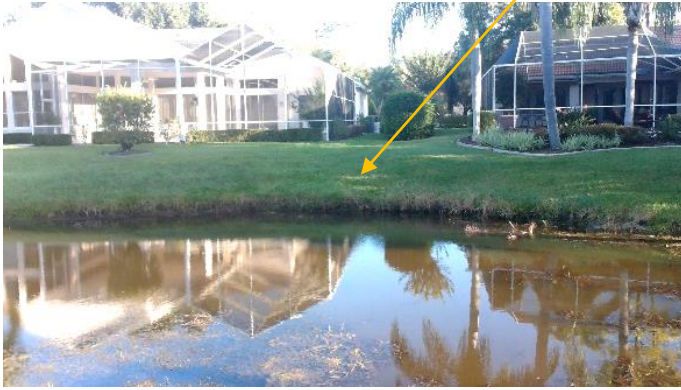
2) St. Andrews drain pipe to Silverthorne ponds-clear pipe to pond (#1 north green). **\$3665.00**

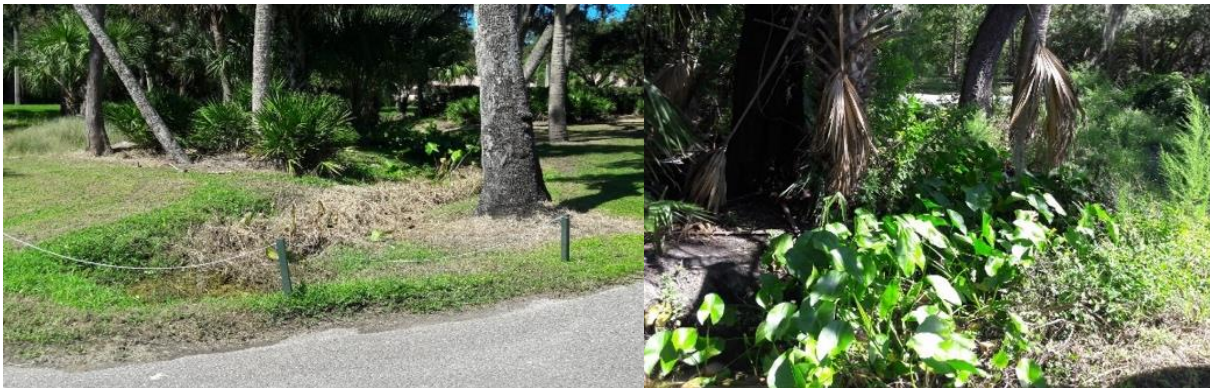
3) Sunflower at # 12 south fairway-remove vegetation from two ditches. **\$1250.00**

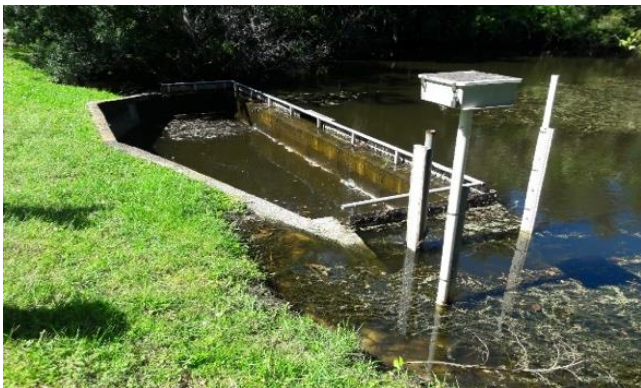
4) Pump house at Cluster 4 on South Woodlands Drive-install rip rap on both sides of control structure. **\$475.00**

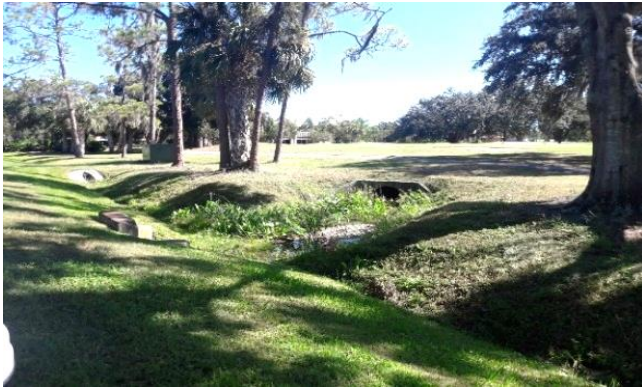
5) East Lake Woodlands Parkway at #18th south green-clean out silt and vegetation in front of culverts. **\$2300.00**

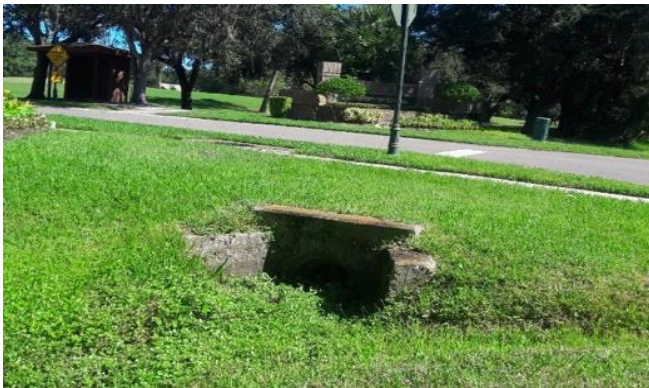
6) Woodlands Parkway at Holly Hill (Woodlands Estates exit)-clear mouth of culvert. **\$730.00**

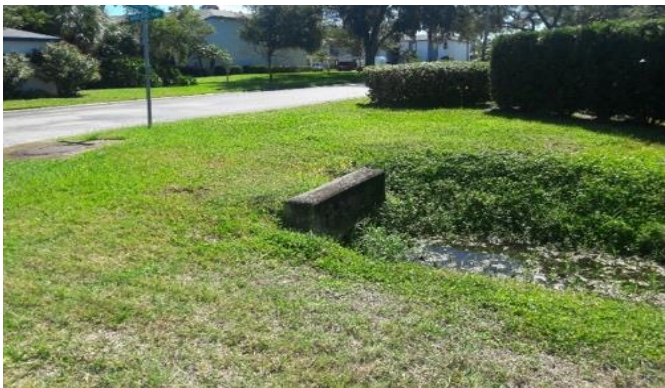
7) Woodlands Parkway at Holly Hill (Cypress Estates entry)-clear mouth of culvert. **\$685.00**

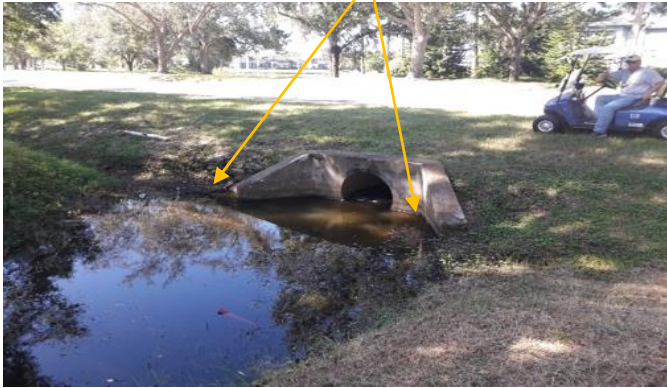
8) East Lake Woodlands Parkway at #17 south green-install rip rap on both sides of headwall. **\$685.00**

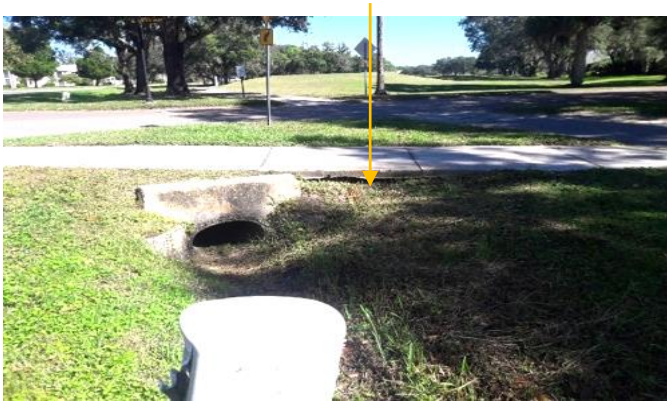
9) East Lake Woodlands Parkway at South Woodlands Drive (between #17'south green and #18 south tee box south)-repair undermined sidewalk. **\$375.00**

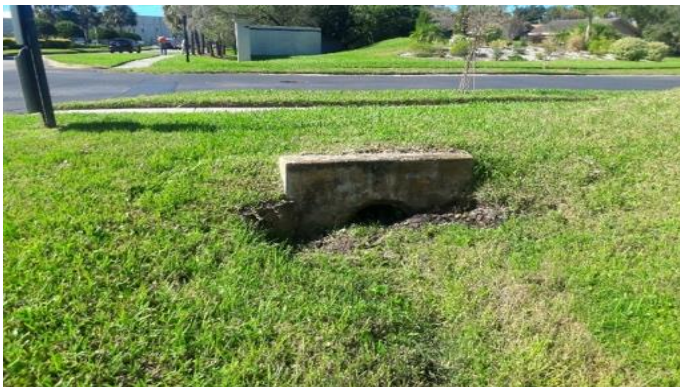
10) East Lake Woodlands Parkway at Eric Court (Lake Shilo)-clear mouth of culvert and jet. **\$875.00**

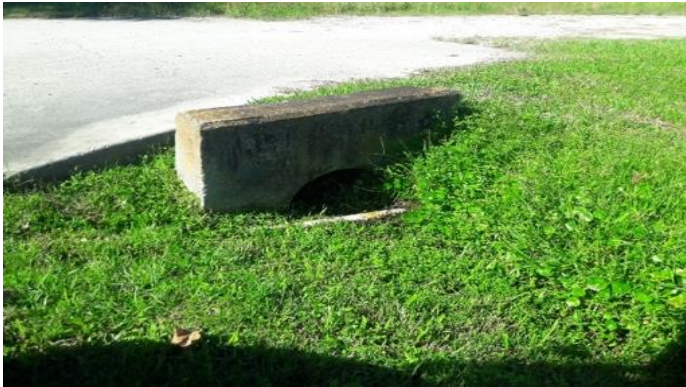
11) East Lake Woodlands Parkway entrance to power easement (staging area behind pool)-clear mouth of culvert and jet. **\$875.00**

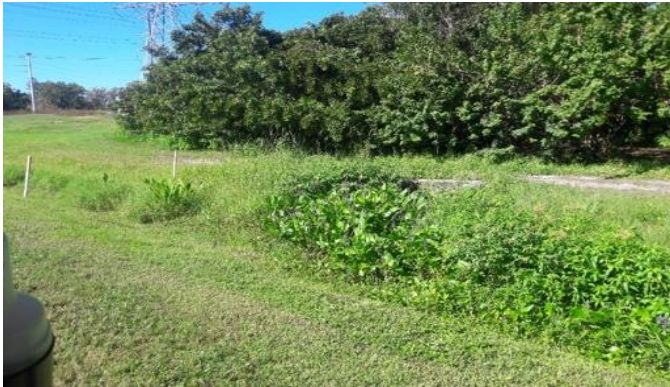
12) East Lake Woodlands Parkway behind pool (across from 318 south green)-clear vegetation from mouth of culvert. **\$875.00**

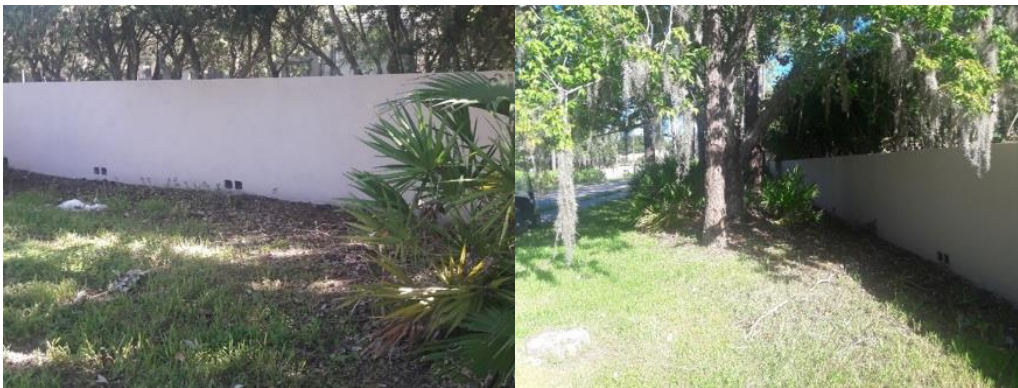
13) Aberdeen wall-install French drainage system along the base of wall. Approximately 300 linear feet. Approximately \$4500. **\$15.00 per ft**

Install sump (box) and connections. **\$17,635.00 – Estimate #247**

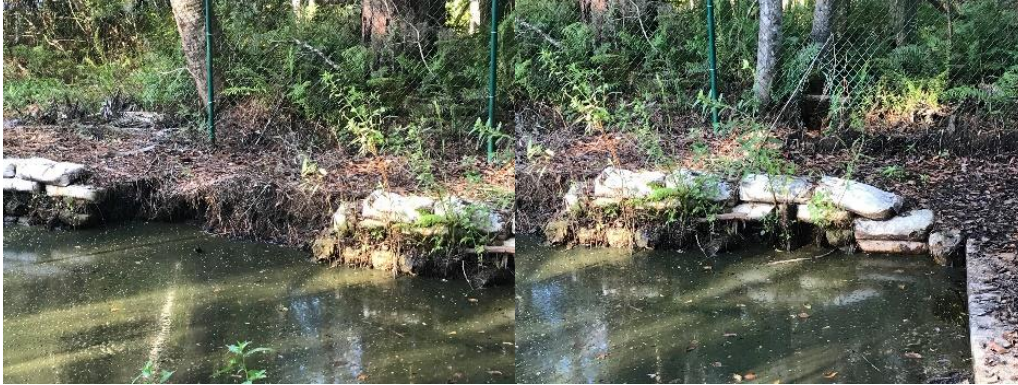
14) East Lake Woodlands Parkway at Greenhaven 3-repair sump. **\$8740.00**

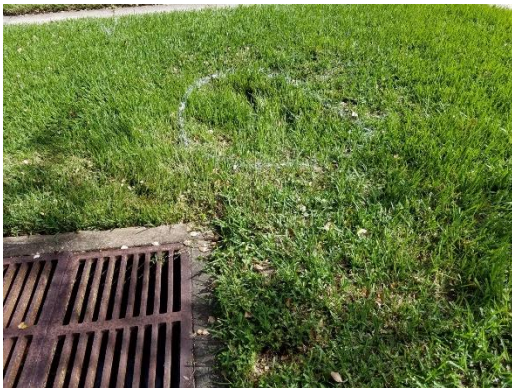
15) Behind lot 28 at Cluster 4 line from Woodlands Plaza Shopping Center crossing #16 south fairway-suspected pipe joint repair needed. **\$6000.00 estimated cost**

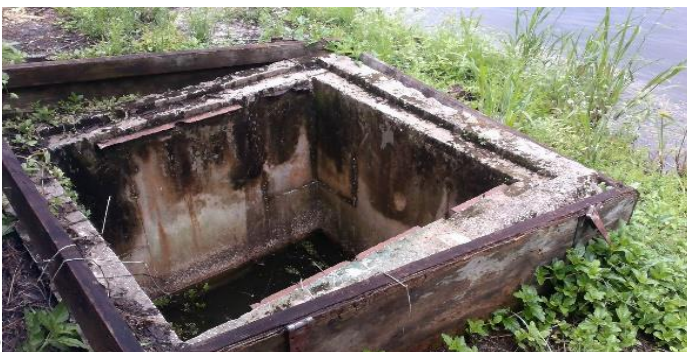
16) Nursery Rd-fabricate grate for wet well. Proposal requested by East Lake Water. **\$2400.00**

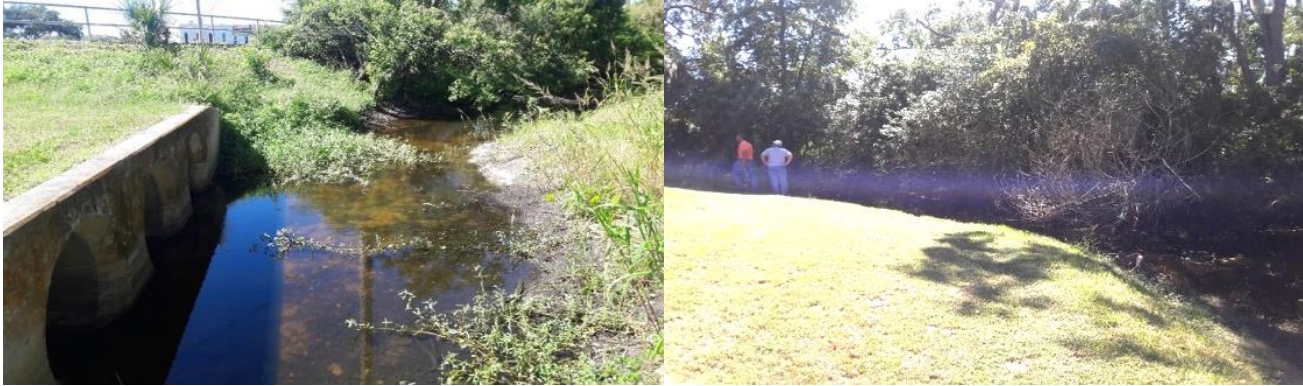
17) Moccasin Creek along Tampa Rd-clear vegetation on both side of creek behind #15 south tee box.

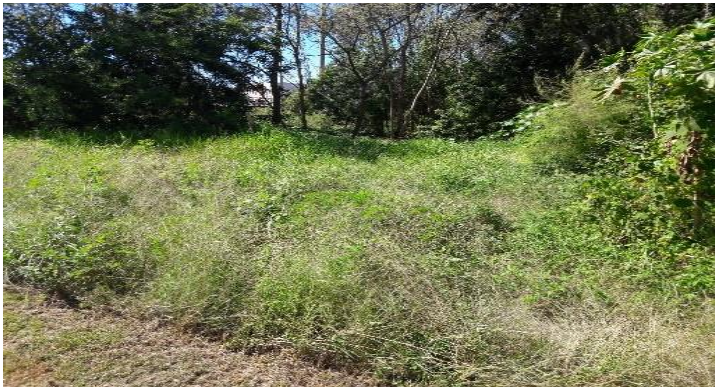
18) Moccasin Creek along Tampa Road at #14 south green-needs to be bush hogged. **\$650.00**

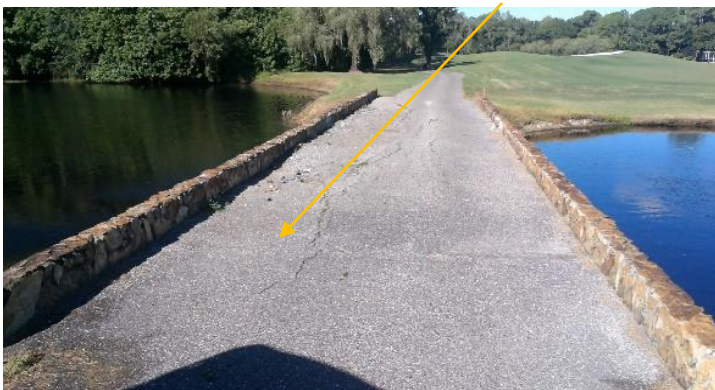
19) #15 north/ green/# 16 north tee-assumed failure of drainage pipes underneath cart path structure.

TBD after inspection – Inspection Cost \$4000.00

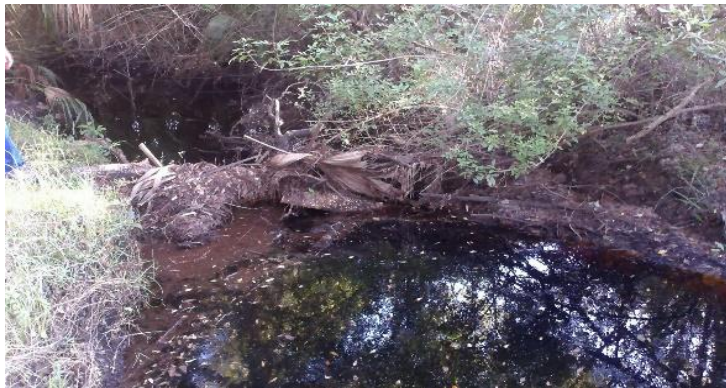
21) East side of #4 north green-tree lying across the creek. **\$275.00**

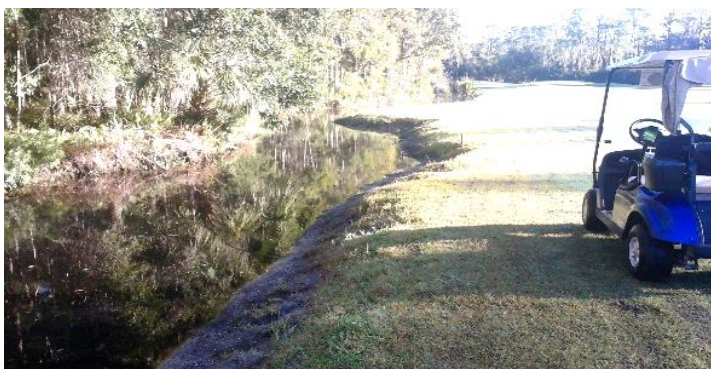
22) Channel on # 3 north fairway-repair creek bank, dead Bermudagrass. The Association previously seeded the bank and installed geo-textile fabric to hasten the seeding. Erosion will now cause sediment to spill into the creek until the bank is again stabilized. **\$9500.00**

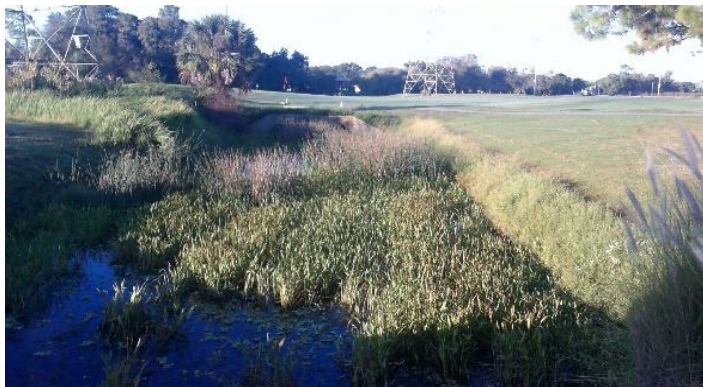
23) #1 north bridge to driving range at power easement-remove vegetation. **\$18,500.00**

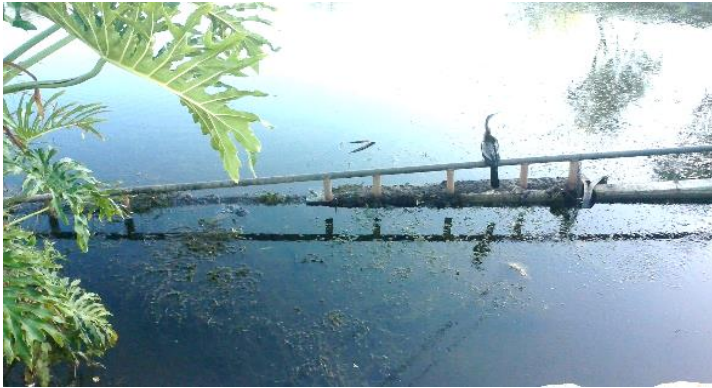
24) #1 north bridge to fairway-repair weir. **\$6800.00**

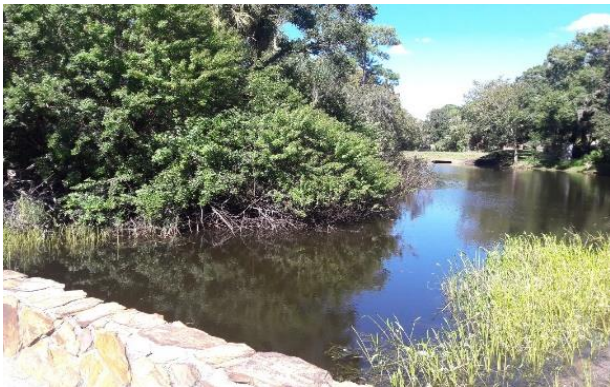
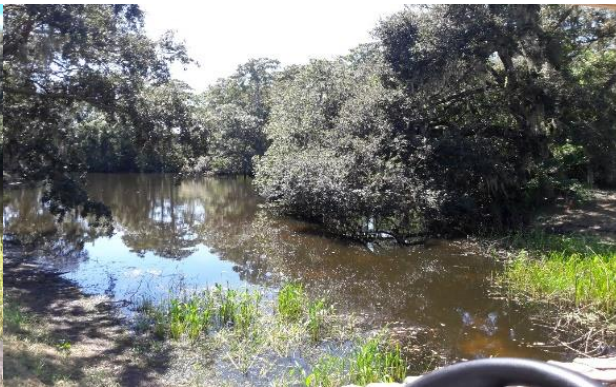
25a) #15' south tee box from bridge
Remove low hanging tree limbs
\$2590.00 for both pictures

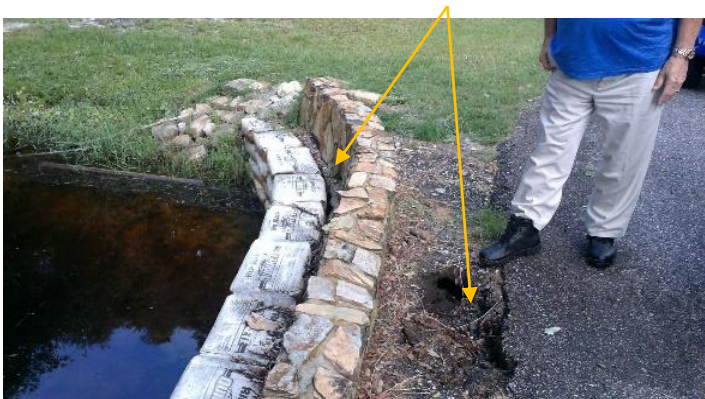
26) Bridge at #4 north green-repair leaning wall and hole forming along carpath. The wall behind the rip-rap is leaning, leaving a void between the two walls. Rainfall can get between the wall and rip-rap causing erosion. The hole along the edge of the carpath is weakening the structural integrity of the path. **\$42,000.00**

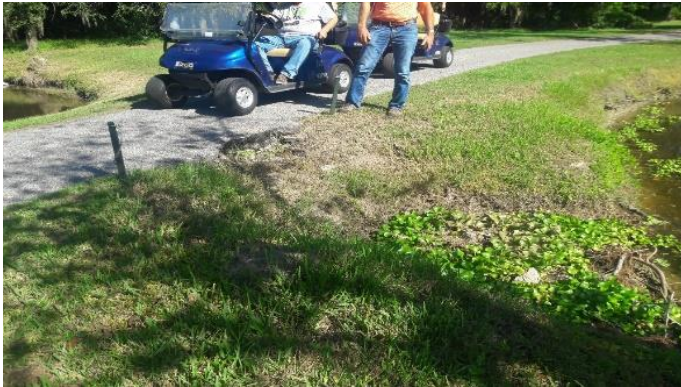
27) Repair drainage under cartpath at #18 north green at East Lake Woodlands Parkway.
