Investigative Report on ELW Master Drainage for the Community Association

Introduction

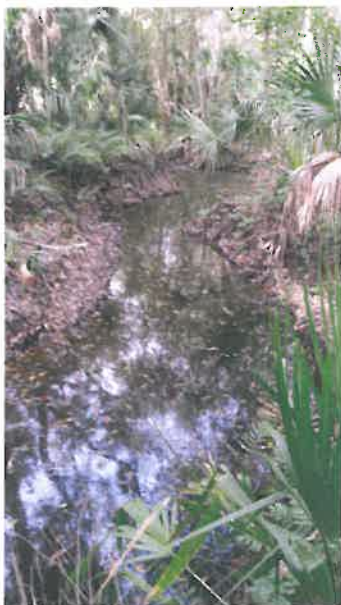
View downstream of Structure 2FL-1

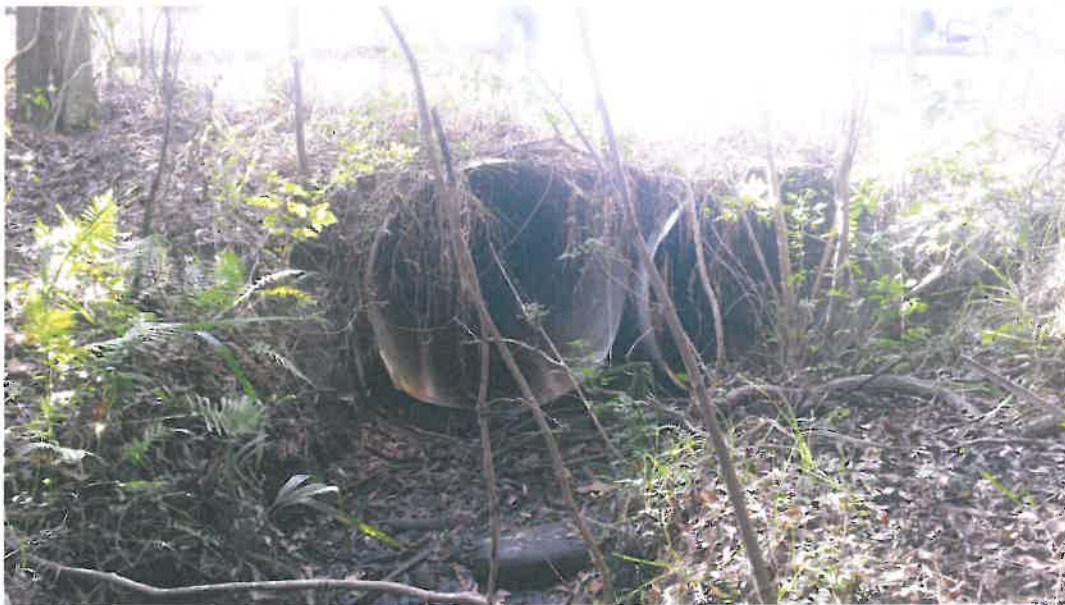
Structure 1SU-1

Channel 1SU also conveys offsite Lockheed Martin flows, and flows from Cluster Homes Unit 5. The Channel starts as a north-south ditch system running parallel to Sunflower Drive, east of Cluster Homes Unit 5, and then continues through an underground pipe system located on the southeasterly corner of Cluster 5, before discharging under SR 584. The channel and structures were visually inspected and appeared be to functioning unimpeded.
